**INVESTIGATION OF GEO-ENVIRONMENTAL HAZARDS AND
RECLAMATION OF ABANDONED BORROW PITS, SOUTH -
EASTERN, NIGERIA**

**A THESIS SUBMITTED TO
THE POSTGRADUATE SCHOOL
FEDERAL UNIVERSITY OF TECHNOLOGY, OWERRI**

**IN PARTIAL FULFILLMENT OF THE REQUIREMENTS FOR THE
AWARD OF THE DEGREE OF MASTER OF SCIENCE (M.Sc.) IN
ENVIRONMENTAL GEOLOGY**

FEBRUARY, 2016

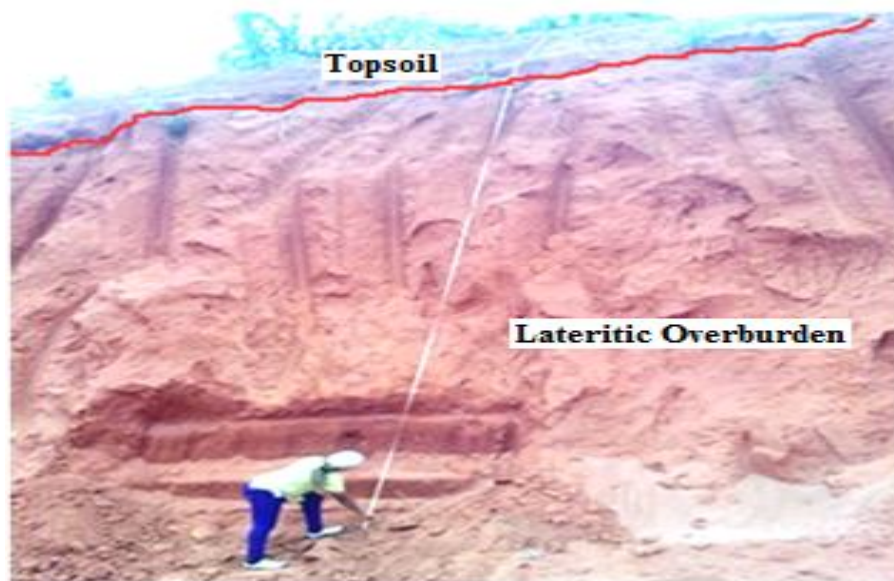
The soil is mostly sandy and gravel-like. The presence of trees, shrubs and grasses is responsible for the dense vegetation within the areas. The topsoil, less than 1 m thick, consists of dark humus soil for agriculture. This top soil is followed by the reddish lateritic soil which constitutes the borrow material. Thickness of overburden or the borrow material as measured in Emekuku pit is 8 m (Plate 1). The selective mining of sand causes dangerous landscape in Ihiagwa pit (Plate 2a,b), further excavation of the water saturated sand and gravel beds for building and other engineering projects other than roads, form dangerous landscape; triggers erosion, form cavities or cause landslides.

Plate 1: Emekuku field measurement of overburden thickness

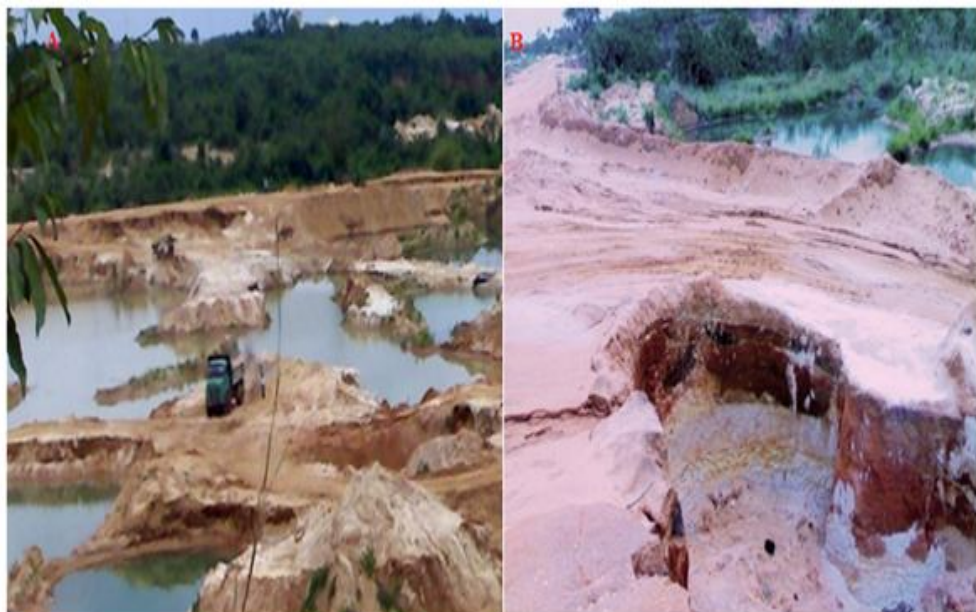
Ihiagwa

Plate 2a: Selective mining of sand causing dangerous landscape
b: Access roads and drive way to the pits is often death traps caused by erosion

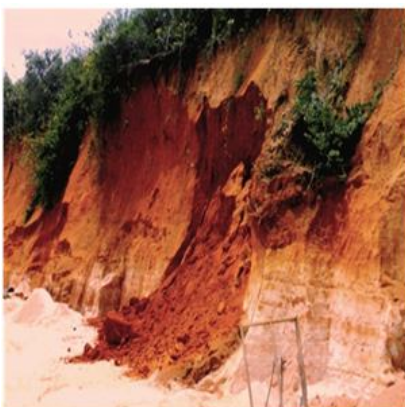
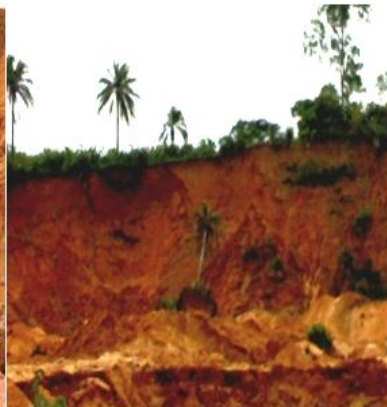
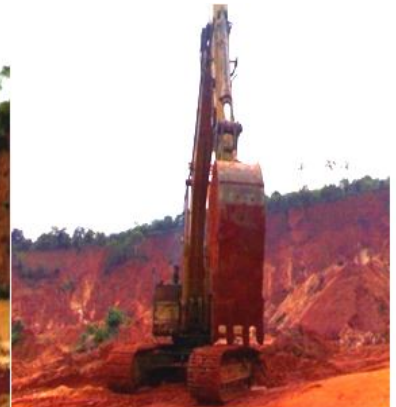
With active fresh slumping surface of the lateritic soil constituting the overburden, sliding of the lateritic face goes on with falling of trees due to deep excavation that leaves very unstable pit slope angle. Often this results in accidents, loss of live and destruction of excavators (Plates 3a, 3b and 3c).

Plate 3a: Abandoned borrow pit showing old slide surface and recent slumping
 b: Active borrow pit with rapid sliding and palm trees hanging next to pit crest often sliding and causing damages to the excavator
 c: Heavy duty excavator at work

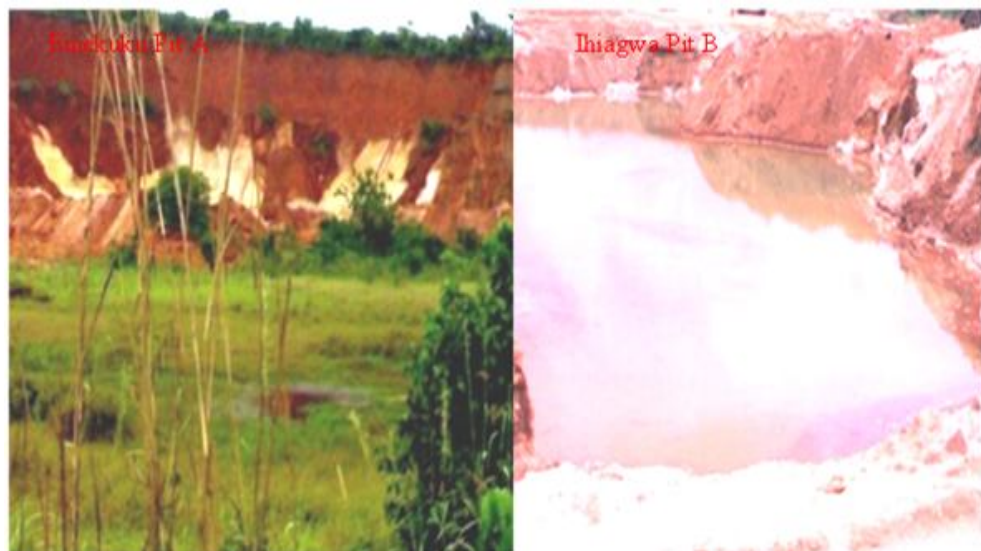
Soon after, abandoned borrow pits in the area could turn to marsh land or ponds (Plate 4a, b). This situation reduces environmental quality by breeding of mosquitoes, polluting the groundwater, often there is loss of life as children swim in the pond or fetch water from the pond. Prevalence of tension cracks on abandoned pits (Plate 5a, b) and mud cracks on dried marsh land in the area also facilitate infiltration and transport of pollutants to groundwater. Structural failure is initiated when the material is stressed to its strength limit, thus causing fracture or excessive deformation. Overburden stress, increasing rainfall intensity and saturation and fracture due to excavation initiate plane of failure. This situation reduces cohesion, initiates plane of failure which constitutes a sliding surface as soon as the shear strength is overcome.

Plate 4a: Borrow pit turned marsh land or swamp 4b: Turned pond,

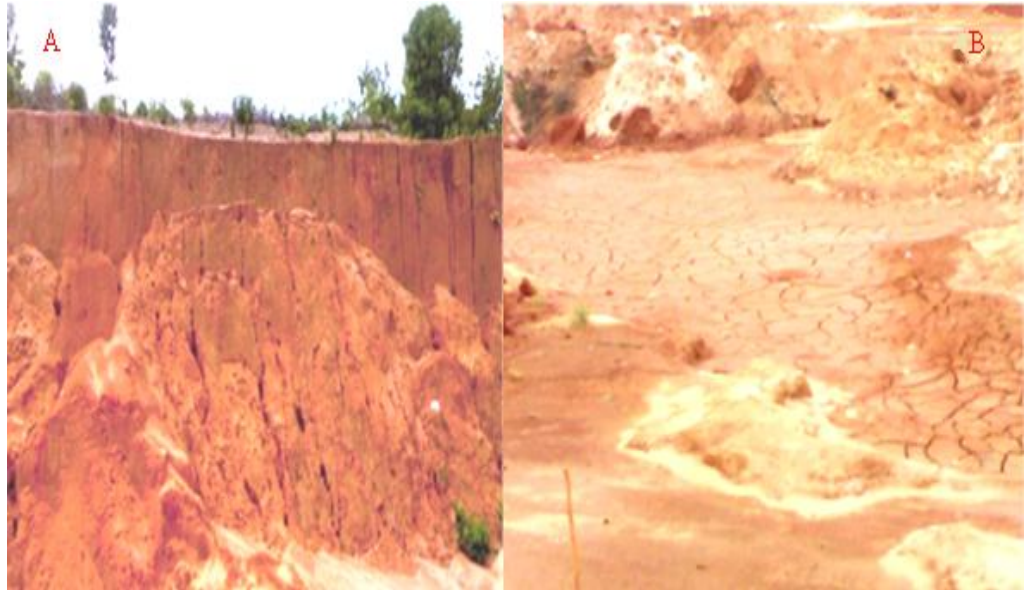
Plate 5a: Tension cracks appear as pit wall and slide surfaces get older, thus reducing slope stability of the pit.

b: Prevalence of mud crack indicate rapid infiltration band possibility of groundwater contamination in the area.

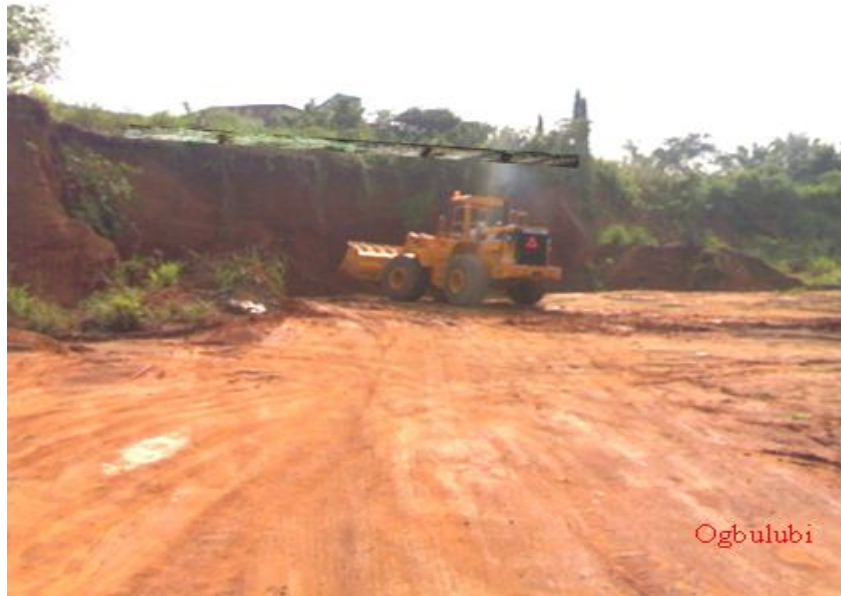
At Ogbulubi borrow pit site, about 20 m from the edge of the abandoned borrow pit, is a fence and story building under threat of sliding (Plate 6). Because of the fact that heavy duty equipment like bulldozers, pay loader and trucks were used for excavation and loading of the laterite soil to designated construction sites, the equipment have the tendency of causing vibration that sends lateral waves to the surrounding structures which also weaken the foundation of the structures and cause displacement. Should there be any slight rain, the pore spaces created will be avenue to transfer water and finally produce cracks that will make the structure collapse. The owner of the story building is already in court with the pit operators, yet excavations were still in progress. Incidents of slide affecting a fence and or building will certainly cause a huge economic loss.

Plate 6: Family home; a duplex, fence threatened to collapse by next sliding as excavation still goes on

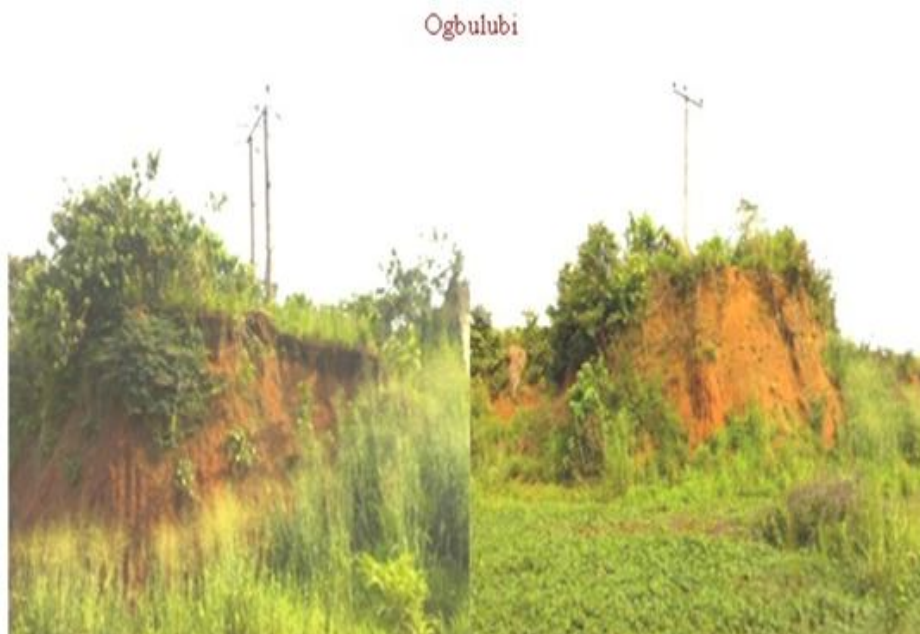
On top of one of the abandoned borrow pits at Owerri-Okigwe highway is a high tension electric pole (Plate 7).

Plate 7: High tension pole hanging at the crest of an abandoned borrow pit, may collapse by the next sliding

From the edge of the slope to the high tension pole is about a distance of 20 m. There is a thick vegetation cover of India bamboo which has stabilized the soil from sliding. But that does not guarantee the safety of the pole from sliding after any heavy rain. The high tension pole poses a lot of environmental hazard to the residents and travelers plying that route. If there is any heavy down pour of rain, there will be ground water movement that will weaken the soil material. There are great environmental and social implications if the pole should collapse. Firstly it will lead to paralysis of commercial and industrial activities for communities that are linked to the high tension pole. It can also lead to death if the pole falls on buildings and human beings.
