**GEOTECHNICAL ASSESSMENT OF AKPULU GULLY
EROSION SITE IN IDEATO NORTH LOCAL
GOVERNMENT AREA OF IMO STATE, NIGERIA**

**THESIS SUBMITTED TO THE POSTGRADUATE SCHOOL
FEDERAL UNIVERSITY OF TECHNOLOGY OWERRI**

**IN PARTIAL FULFILLMENT OF THE REQUIREMENTS FOR
THE AWARD OF THE DEGREE (MASTER OF SCIENCE) M.Sc.
IN ENVIRONMENTAL TECHNOLOGY
(GEOLOGY/ENVIRONMENTAL TECHNOLOGY OPTION)**

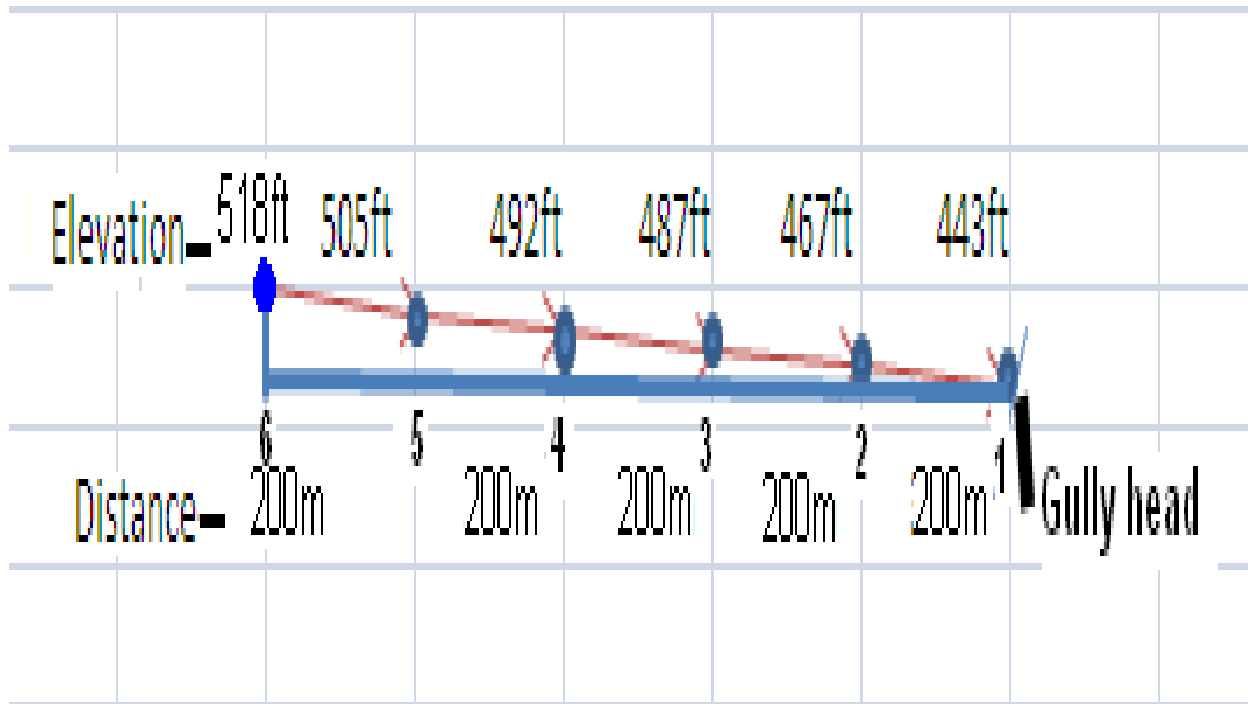
Fig. 2 Natural slope of erosion channel

Five elevation points were measured at 200 m interval from the gully head, and along the natural drainage channel (Figure 2) . A gradual increase in elevation was observed from the gully head to 1.0 km upland. By direct reading using a GPS, the following data were collected (Apendix 2a);

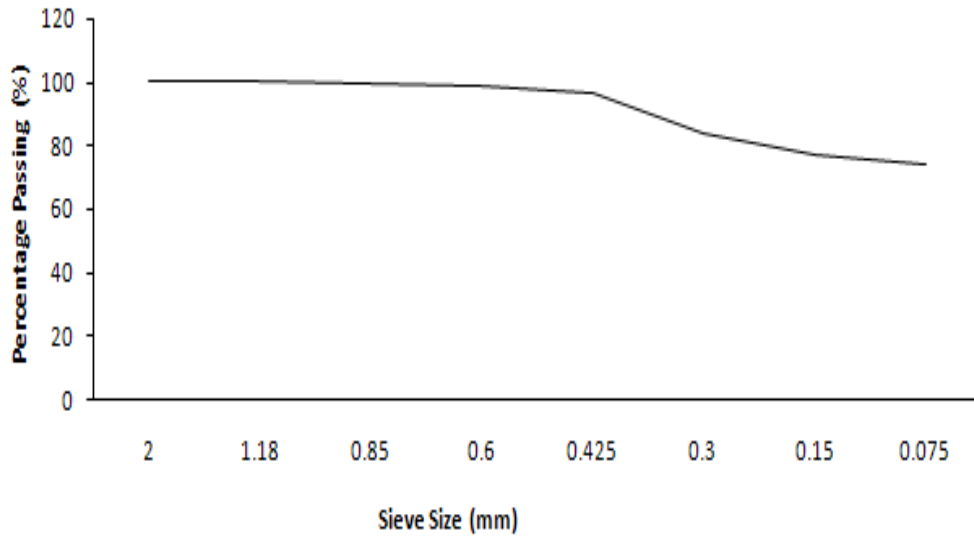
Figure 3a: Grain size distribution showing percentage (%) passing vs sieve size of sample 1

Percentage (%) Gravel: 0.0%
 Percentage (%) Sand: 25.3%
 Percentage (%) Silt } Fine: 74.7%
 Percentage (%) Clay }

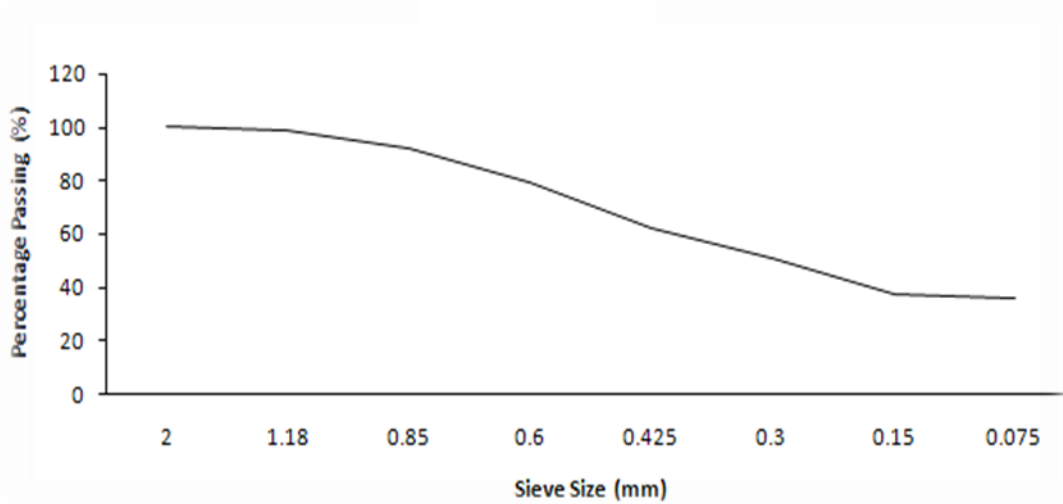
Figure 3b: Grain size distribution showing percentage (%) passing vs sieve size of sample 2

Percentage (%) Gravel: 0.0%
 Percentage (%) Sand: 63%
 Percentage (%) Silt } Fine: 37.0%
 Percentage (%) Clay }

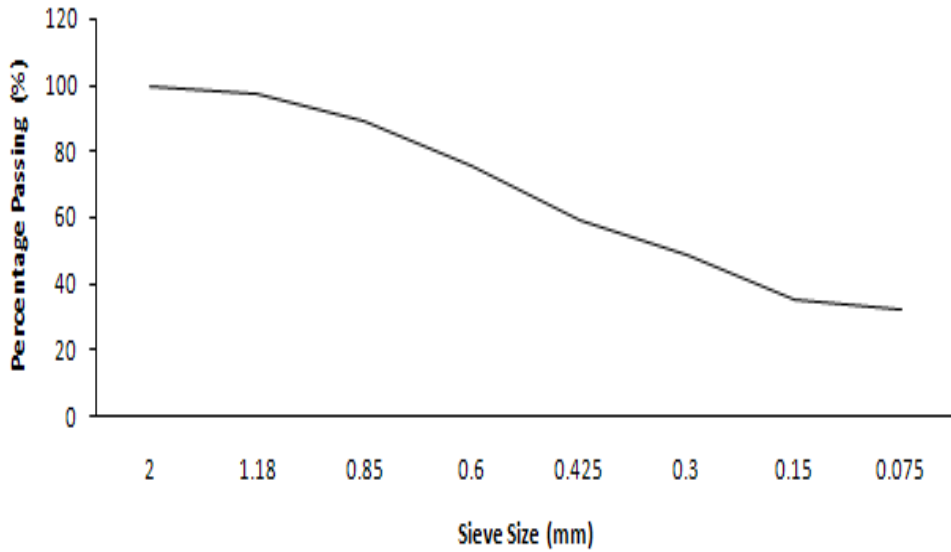
Figure 3c: Grain size distribution showing percentage (%) passing vs sieve size of sample 3

Percentage (%) Gravel: 0.3%
 Percentage (%) Sand: 67.7%
 Percentage (%) Silt } Fine: 32%
 Percentage (%) Clay }

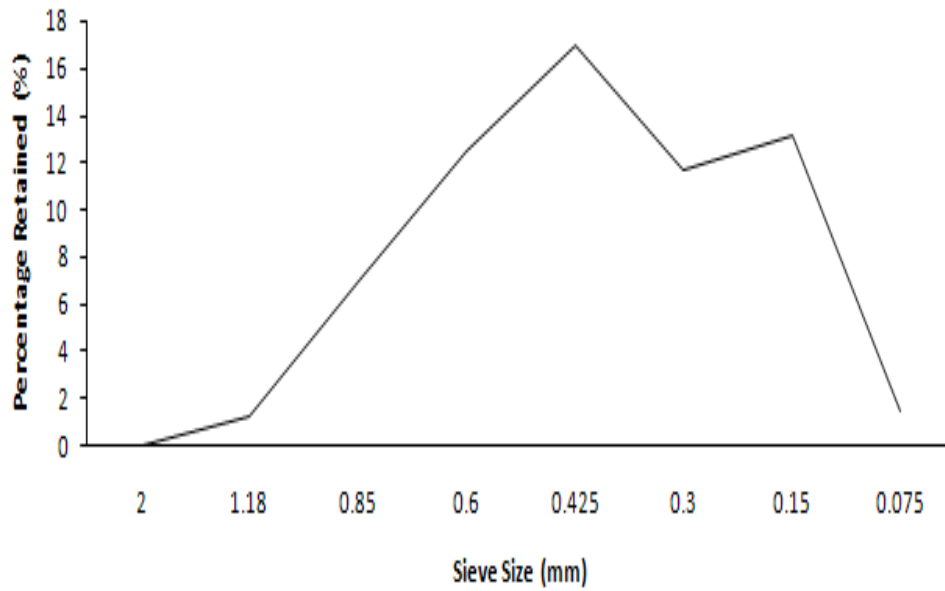
Figure 4b: Grain size distribution showing percentage (%) retained vs sieve size of sample 2

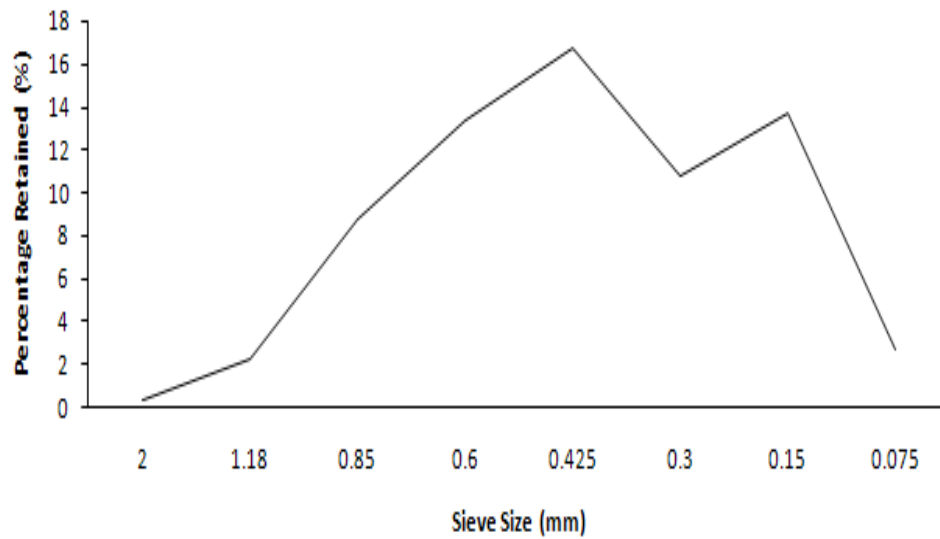
Figure 4c: Grain size distribution showing percentage (%) retained vs sieve size of sample 3

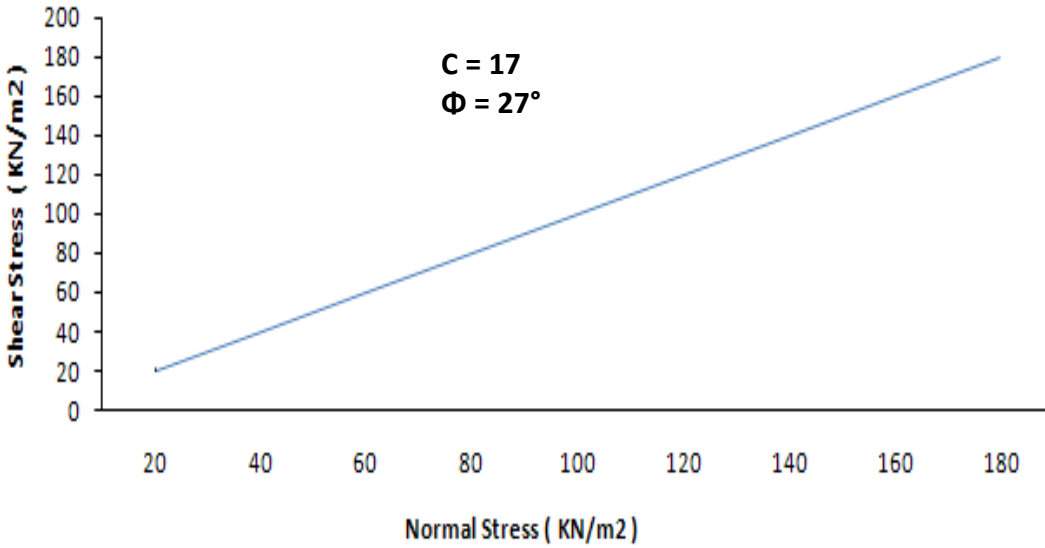
Figure 5a: Shear strength for Sample 1
Average shear strength: 105.6KN/m²

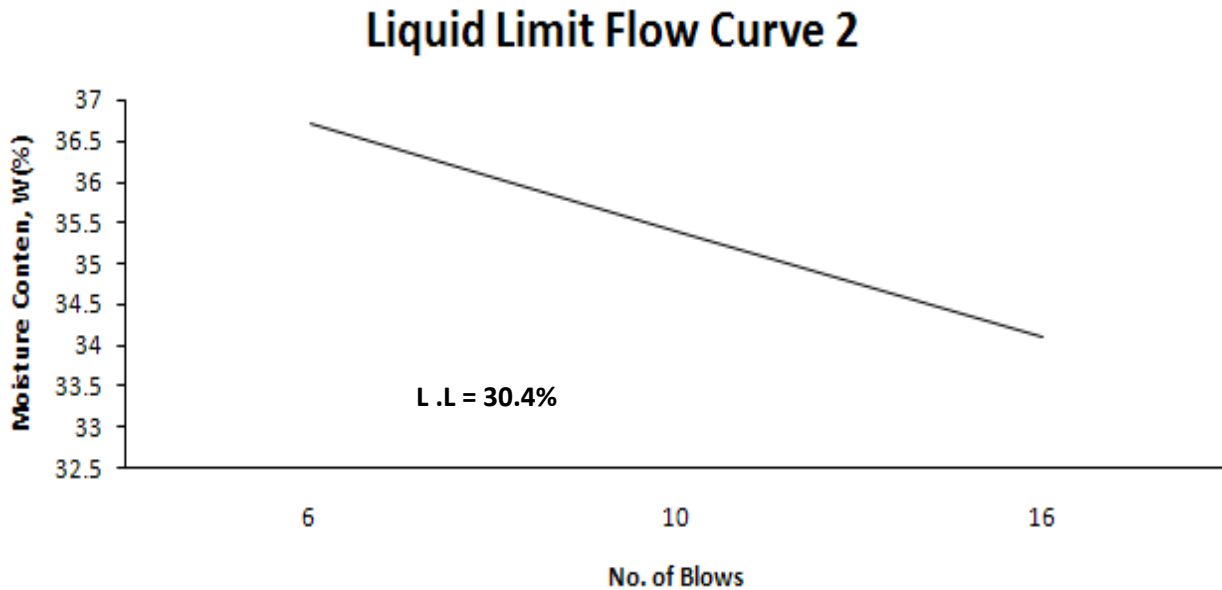
Figure 6b: Plastic and Liquid limit for sample 2

Liquid Limit (LL): 30.4%
 Plastic Limit (PL): 22.75%
 Plasticity Index (PI): 7.65%

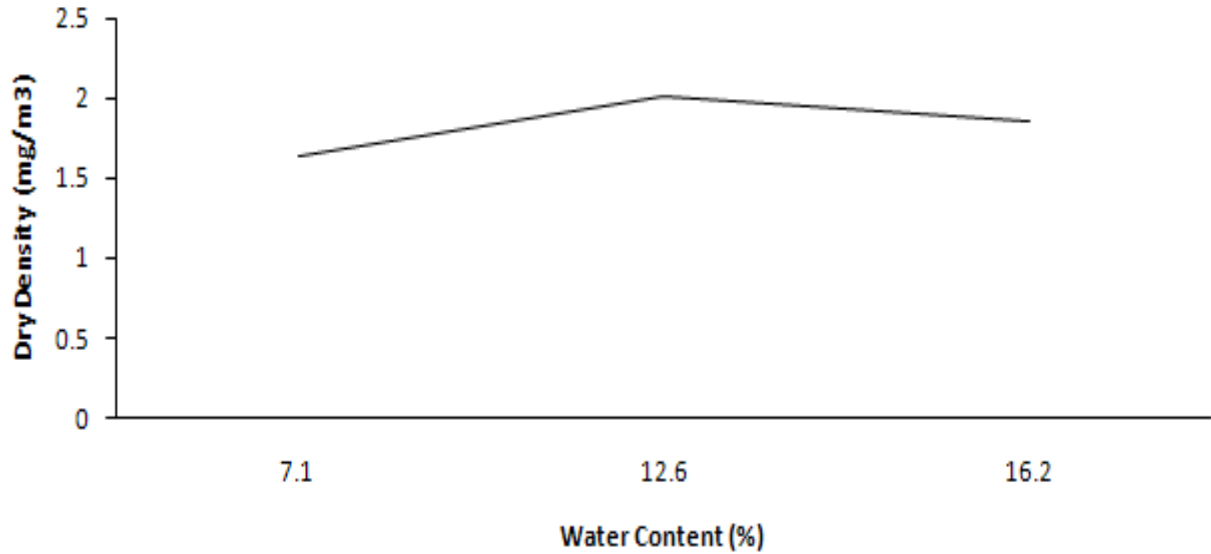
Figure 7a: Compact test for sample 1

M.D.D: 2.01mg/m²

O.M.C: 12.6%

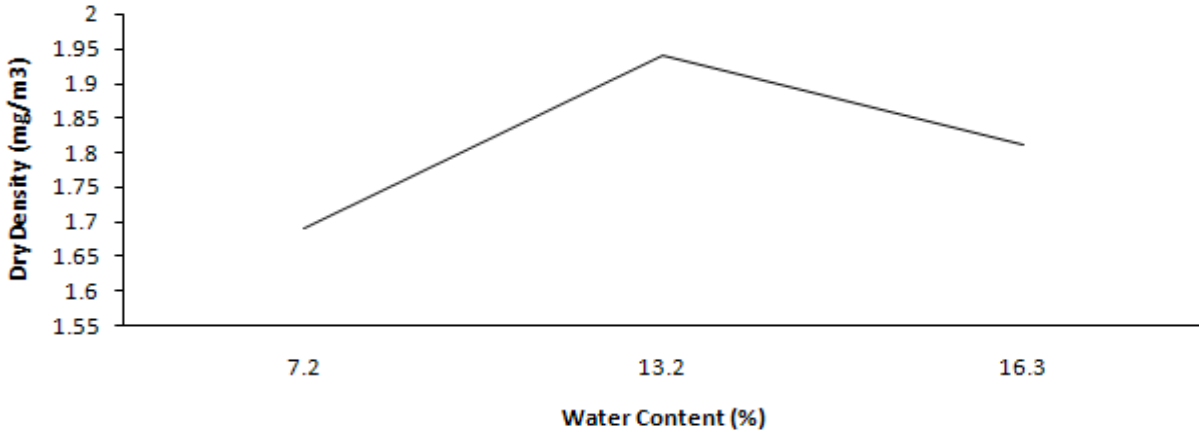
Figure 7c: Compact test for sample 3

M.D.D: 1.95mg/m²

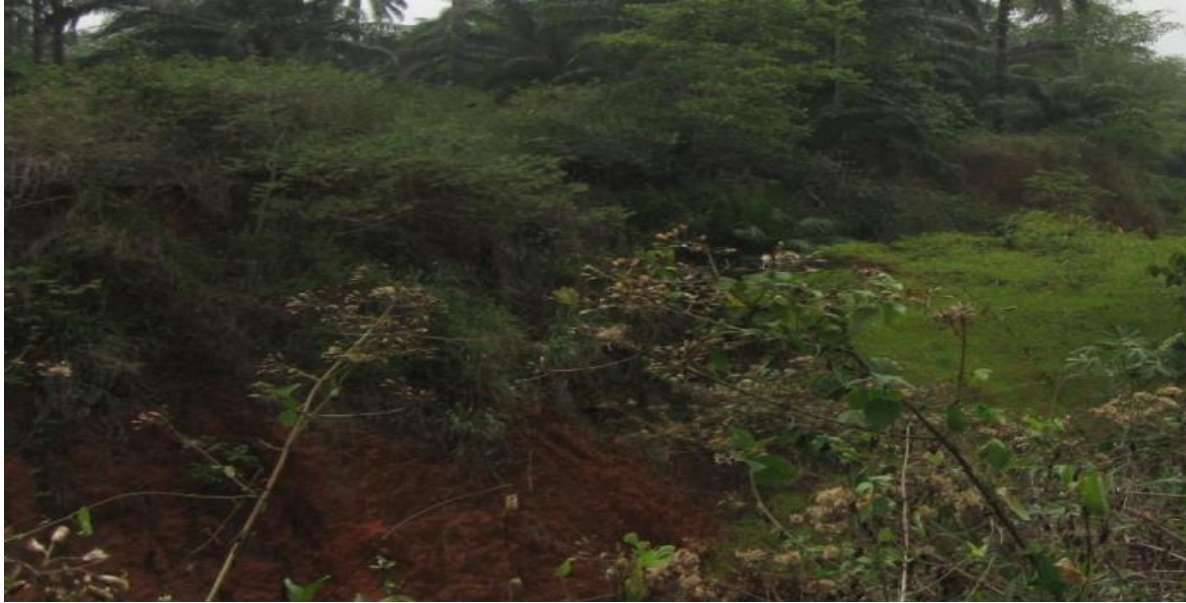
Appendix 1a: showing secondary erosion channel

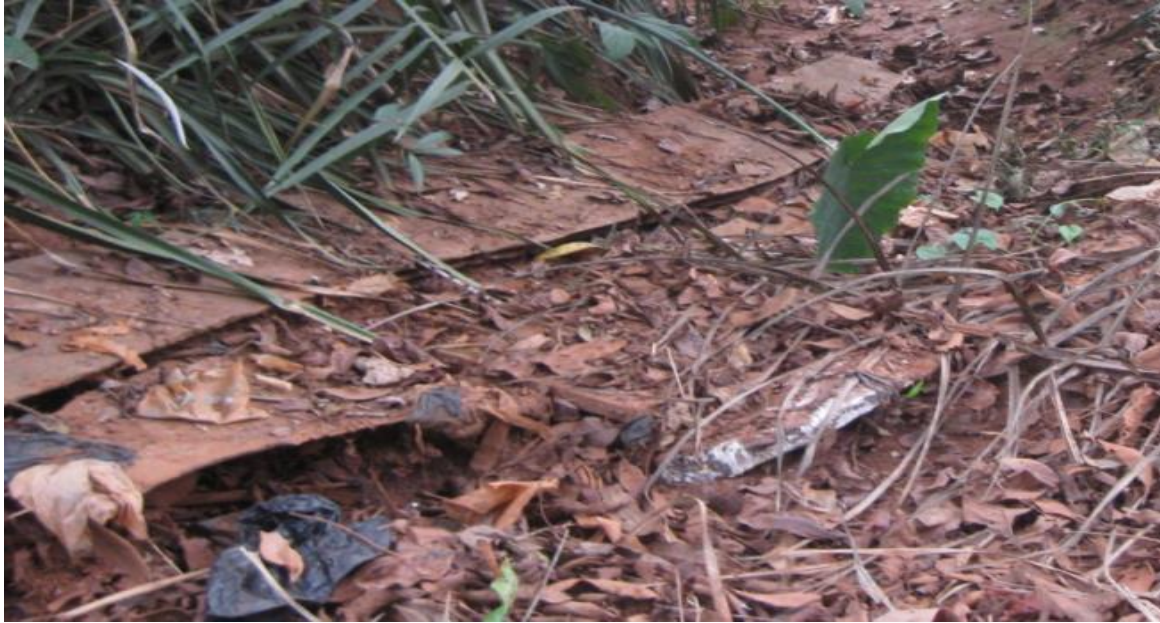
Appendix 1c : showing some materials carried by run-off water

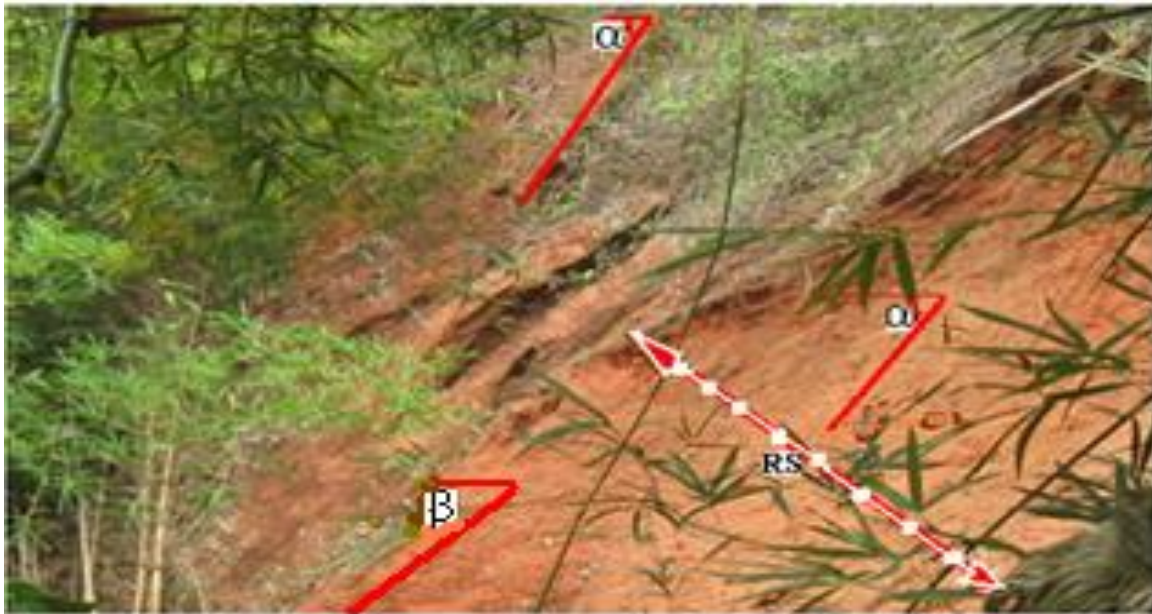
Appendix 1d: showing width and recent slide surface of the study area
