**PROLIFERATION OF PETROL STATIONS: RISKS, IDENTIFICATION
AND DESIGN OF GROUNDWATER QUALITY MONITORING WELLS
IN OWERRI WEST, IMO STATE, NIGERIA**

**A THESIS SUBMITTED TO THE
SCHOOL OF POSTGRADUATE STUDIES
FEDERAL UNIVERSITY OF TECHNOLOGY, OWERRI**

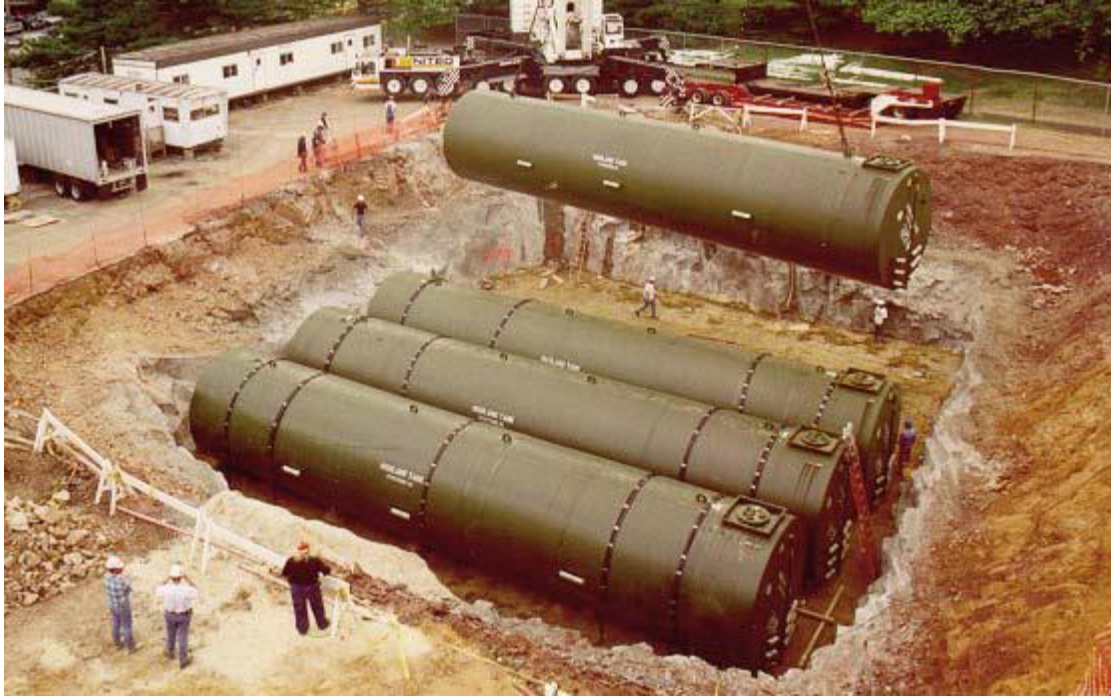
Figure 2.3: A typical UST installation

UST system refers to a storage tank or tanks that have at least 10% of their total combined volume below ground. This includes the tank of any connected piping, additional equipment, and containment system. USTs are commonly used to hold materials such as petroleum products; water, natural gas or sewage. UST systems require constant monitoring and upkeep and are subjected to several types of regulations. Federal regulations apply to USTs holding substances such as petroleum and other hazardous substances. UST systems that are not regulated by FG usually fall under state/or local jurisdiction. Since each type of UST can be subject to different policies, all regulations regarding a UST system should be checked to make sure compliance with all policies, laws and regulations have been met. Some of the regulations applying to USTs include (Sullivan, 2008):

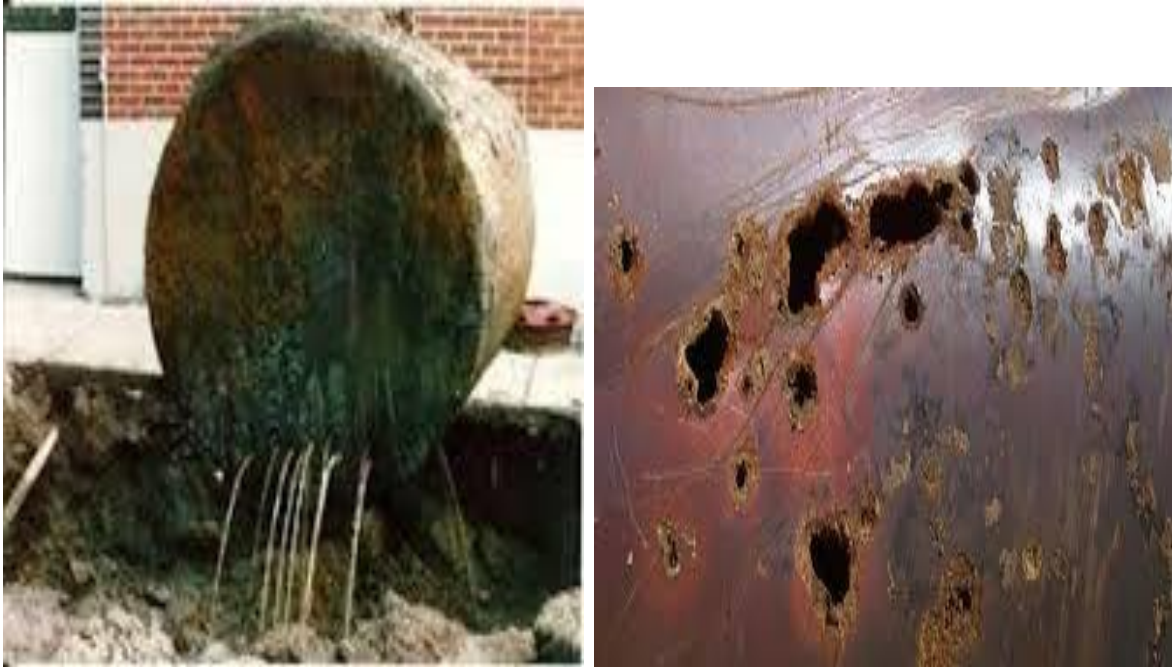
Figure 2.4; Fuel leakage from a corroded UST; Source: DEFRA 2000

Soil corrosivity is a significant factor in petrol station USTs. Soil with $\text{pH} \leq 5.5$ will be highly corrosive to USTs. The factors that contribute to the corrosive potential of soil are aeration, moisture content, temperature, pH, and resistivity. Sandy and Loamy soils have excellent to good corrosion resistance. Soils with very high resistivity have no corrosion potential. As soil temperature tends to 0°C and continues to decrease there is a rapid increase in resistivity with a corresponding decrease in the corrosive potential of the soil. Generally soils are considered “mildly corrosive” if the sulfate and chloride levels are below 200 PPM and 100 PPM, respectively, for soils with pH levels of between 5 and 10, and resistivity greater than 3000 ohm-cm (Arbabi, 2015). According to him, an increased moisture content decreases resistivity of soils, in turn increasing their corrosive potential. Arbabi obtained that when the saturation point of the soil is reached, additional moisture has little or no effect on resistivity.

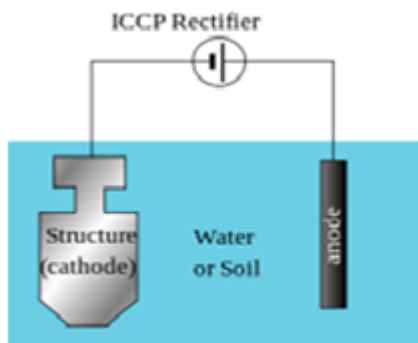
Figure 2.5(a)

Petrol station USTs and metal piping can be cathodically protected in two ways. The most common is with magnesium anodes (Figure 2.5a). Another is with impressed current (Figure 2.5b) using public power supply. The goal is to extend the life of an underground tank by preventing corrosion and rust. Galvanic Protection (Figure 2.5c) uses anodes made of high potential magnesium (AZ-63 or H-1), magnesium alloy, and zinc. Zinc anode is recommended in the sandy coastal area of Owerri west, and in parts of Niger delta where groundwater may be salty. When a tank is totally protected from corrosion, the entire tank becomes a cathode. The duration of protection measured is dependent on the resistivity of the environment in which the tank is installed. If the tank is installed in non-corrosive dry sandy soil (High resistivity), it may be relatively free of corrosion and the

Figure 2.5(a): Protection system with magnesium Anode

anode will last a lifetime. However, if the tank is installed in wet, clayey or chemically contaminated environment (Low resistivity), the anode gets consumed in less time. The anodes have limitations: zinc can be used on land and in seawater, magnesium in freshwater, and aluminium in seawater. Galvanic anode systems have some limitations and drawbacks; for example, they cannot be used where there are stray currents or interference, they do not allow adjustment of the injected current, and the anodes must be replenished after consumption. In impressed current, cathodic protection buried metal structures receive the protection current from an external source or current rectifier installed on the surface and using a set disperser current in the electrolyte consisting of a bed of inert anode: $2\text{OH} - 2\text{e}^- = 2\text{H}_2\text{O} + \frac{1}{2}\text{O}_2$ and electrolytic reaction cathode: $2\text{H}_2\text{O} + 2\text{e}^- = 2\text{OH}$.

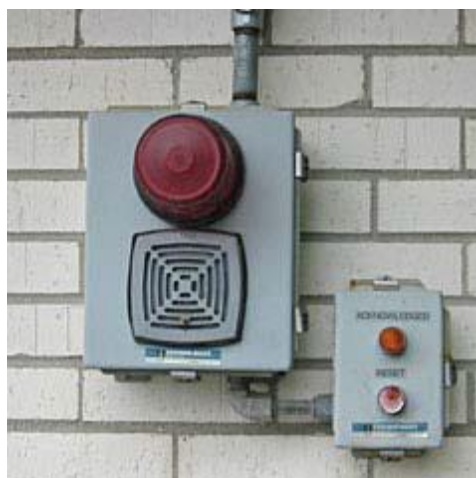
The most common releases from USTs are during filling, either from fill hose disconnection or from overfills. Prior to delivery, an accurate assessment of delivery volume should be made. Verification of tank volume meters with sticking of the tank (and conversion to volume using appropriate tank chart) should be conducted. Delivery volume should be such as to not fill the tank above 90% of capacity. Overfill alarms (audible, strobe, or both), which operate based on floats within the tank, are usually set at 85% to warn delivery person to cease filling, with another high level alarm at 90%. These alarms should be adjacent to the fill connection area to ensure they are seen and heard (www.yale.edu/ehs)

Figure 2.6: Audible and strobe overfill alarm

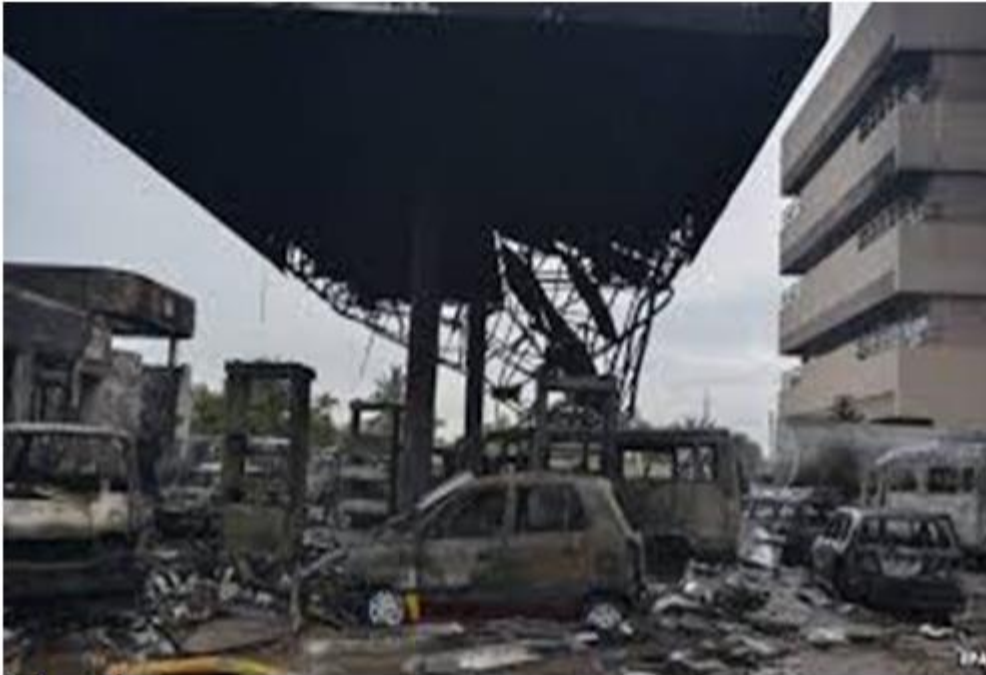
Figure 2.7a

Igniting cigarette lighter, use of cell phones, cars with electrical faults, car engine steaming while pumping fuel, etc are frequent causes of fire in petrol stations. Some 150 people have died in a fire at a petrol station in Ghana's capital, Accra as shown in Fig 2.7a below. It is thought that people were in the petrol station

sheltering from the downpours when the fire broke out. Flood helped cause the fire. The waters "caused the diesel and petrol to flow away from the gas station, and fire from a nearby house led to the explosion" (BBC News June 5, 2015).

Figure 2.7a: Ghana Petrol Station Inferno (BBC News June 5, 2015)

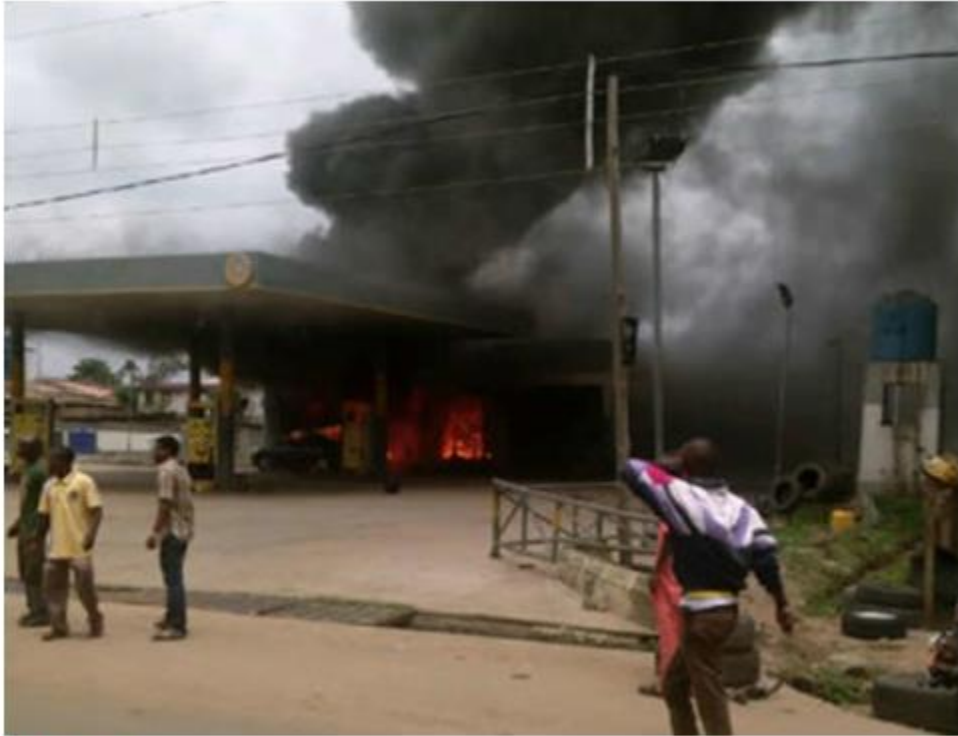
Figure 2.5b

In the Bovas petrol station inferno at Oshogbo, Osun state Nigeria (Plate 2.7b), it was gathered that some children whose ages were 8 and 12 years sleeping in a mini supermarket attached to the filling station lost their lives as the supermarket joined the station into flames around 12pm on Wednesday, 23rd September, 2015. This petrol station was not well equipped as there were no adequate fire extinguishers located in the station. (This Day News Paper 23 Sept. 2015)

Figure 2.5b: Bovas Filling Station Inferno (This Day News Paper 23 Sept. 2015)

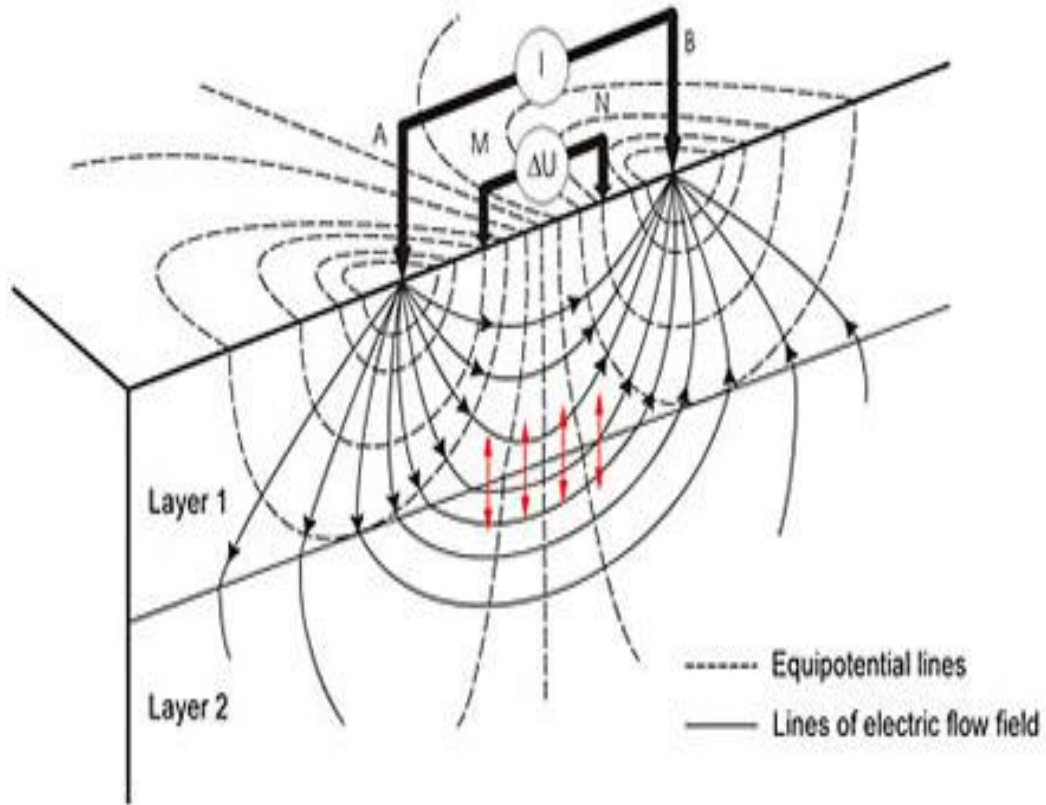
OHMEGA-500 Electrical Resistivity Equipment was used to conduct a Vertical Electric Sounding (VES). Schlumberger configuration was used for a total spread (L) of 320 m. VES station was located 50m away from high tension electric wire with the traverse running normal. A distance of 95 m ($L/2$) was covered on the right of traverse, and another 95 m ($L/2$) was run on the left, in each traverse. All necessary precautions required in geo-electric measurement were duly considered. The survey lasted approximately 1hr 30 min in each location under favourable weather condition. Transmitter electrodes (A, B) were used to inject current into the ground. The current flow between A and B is measured with the potential electrodes (M, N) as shown in Fig 3.2

Fig. 3.2 Point –Measurement Electric Flow

Several 4-point-measurements are taken where the receiver electrodes M , N remain in place and the transmitter electrodes are symmetrically extended outwards. Thus the current penetrates successively deeper into the ground. When the current flow sinks to a layer with different electrical conductivity the current flow field is deformed, this can be measured at the receiver electrodes M , N . From this data a layer model based on the electrical conductivity of the different subsurface materials is calculated as shown in Plate 3.1.

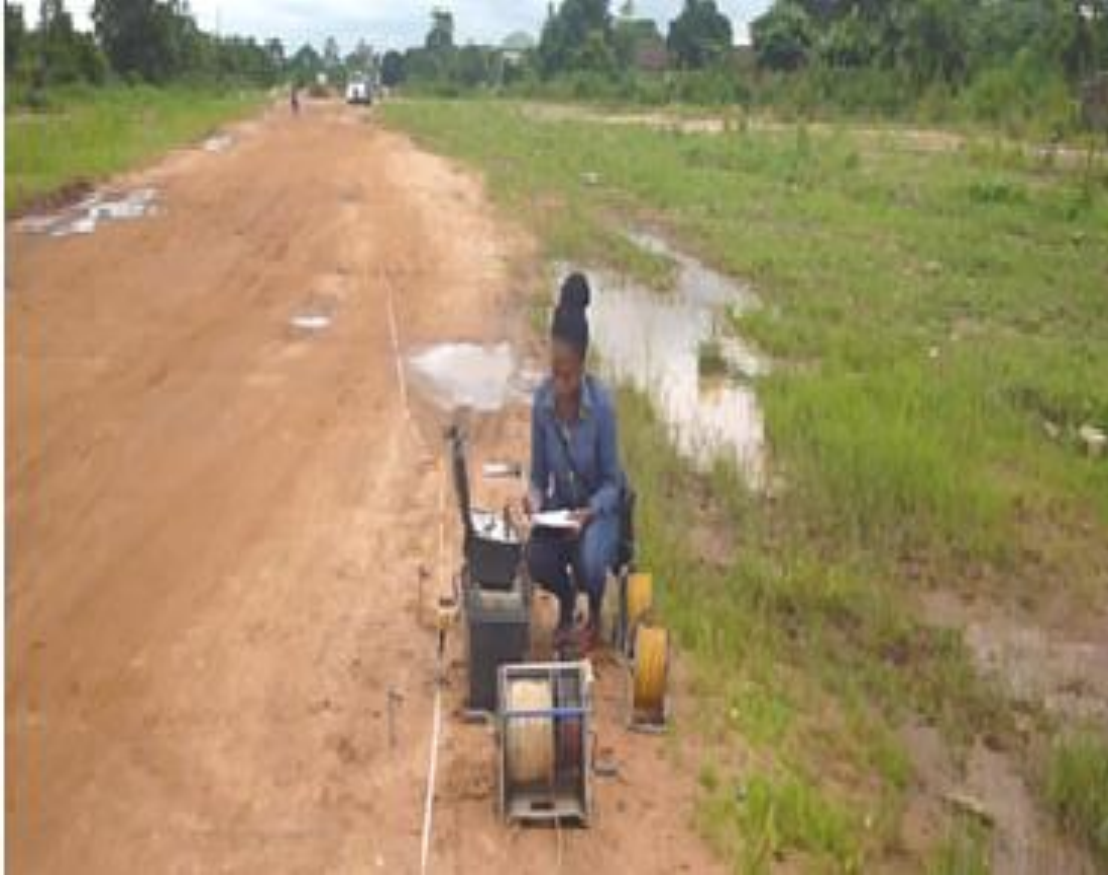
Plate 3.1: VES Field survey

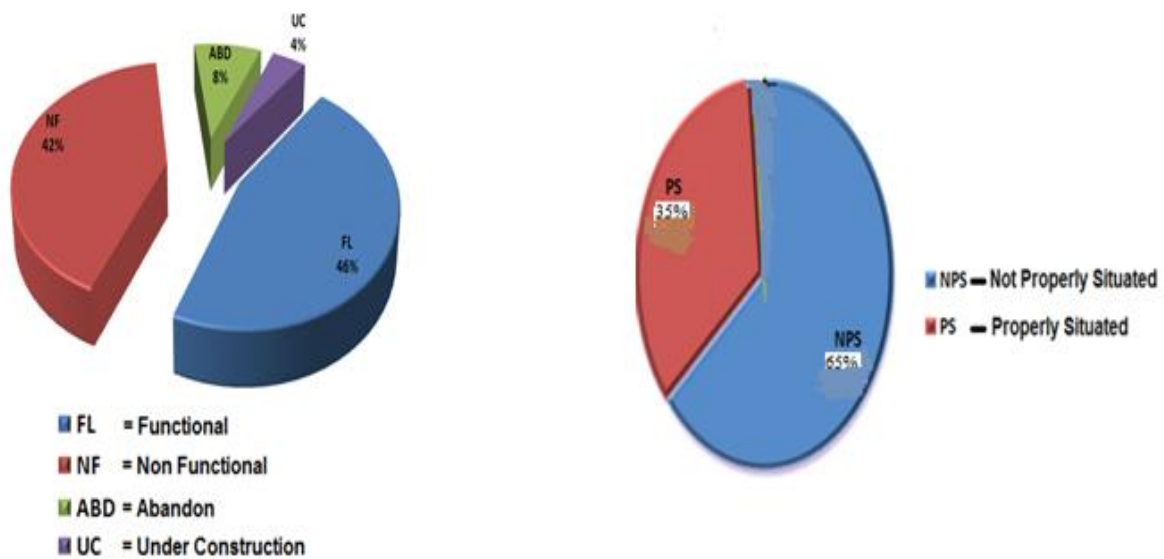
Functional petrol stations were 46%, 42% were non-functional, 8% were abandoned, and 4% were under construction. Also, 64% were not properly situated, 35% were properly situated as shown in (fig 4.2).

Figure 4.2 Graph of Total Petrol Stations against Functionality and Location of all Road

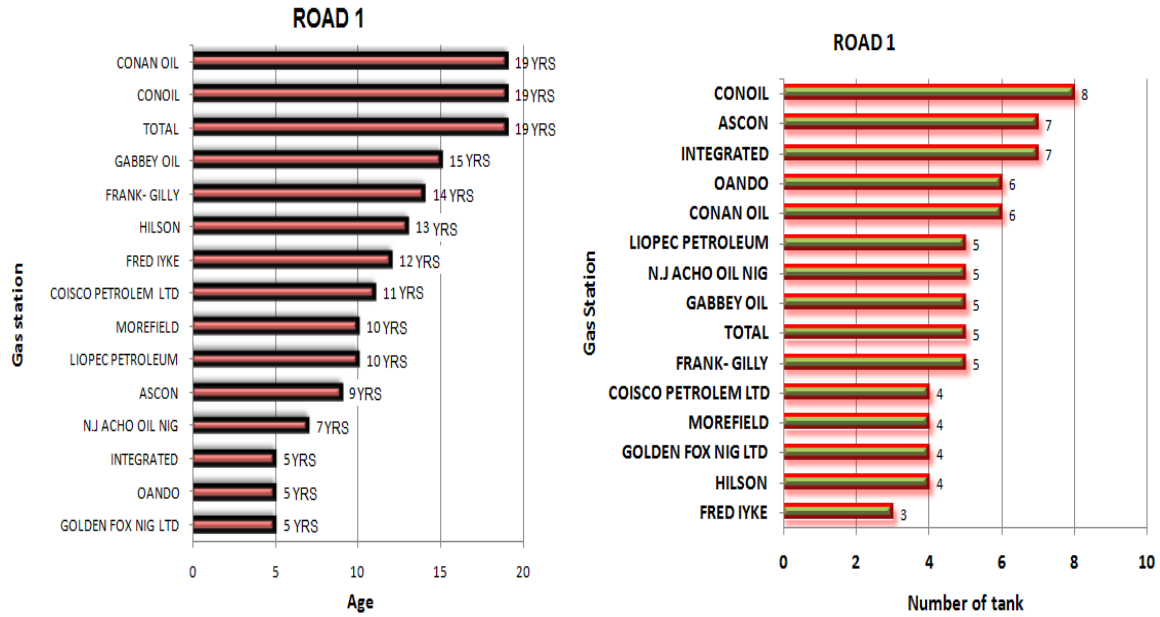
Fig. 4.3; Graph of Gas Stations against Age and Number of USTs for Road 1

Further analysis of this result considered locations of older stations and the possibility of corrosion and leakage of storage tanks. It is concluded that petrol stations between ages of 15 to 22 years are at greater risk of corrosion and leakage, and that any leakage from depth of 3.6 m would easily migrate to the water table at 24.5 m, and transported south-southwest of the area. Geophysics result also show the subsurface geology of the area to consist predominantly of sand and gravel

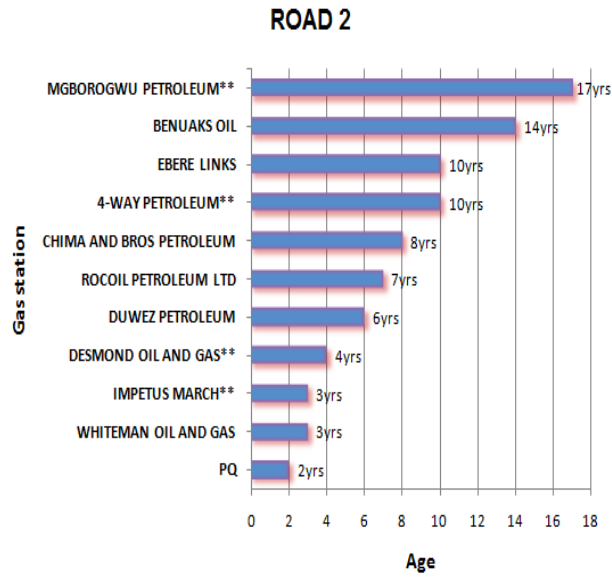
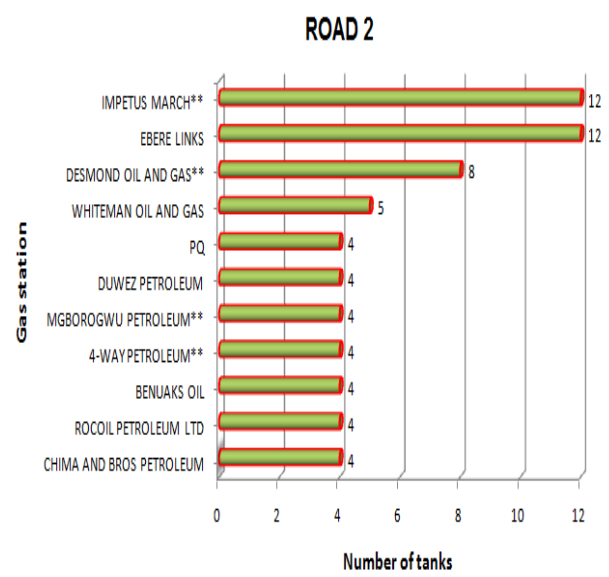
Fig.4.4; Graph of Gas Stations against Age and Number of USTs for Road 2

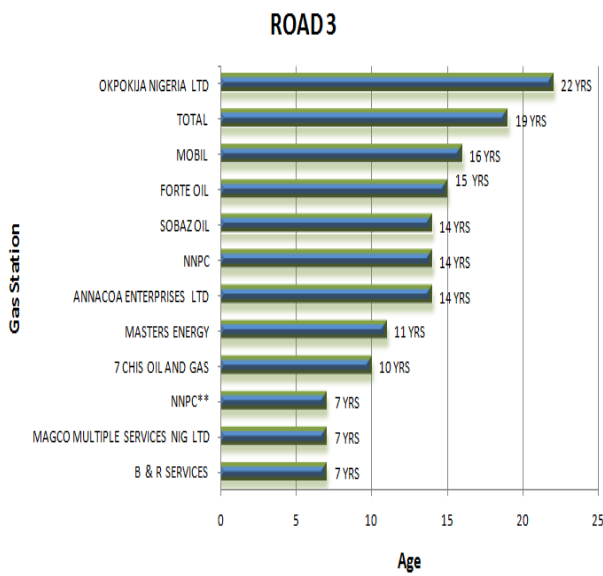
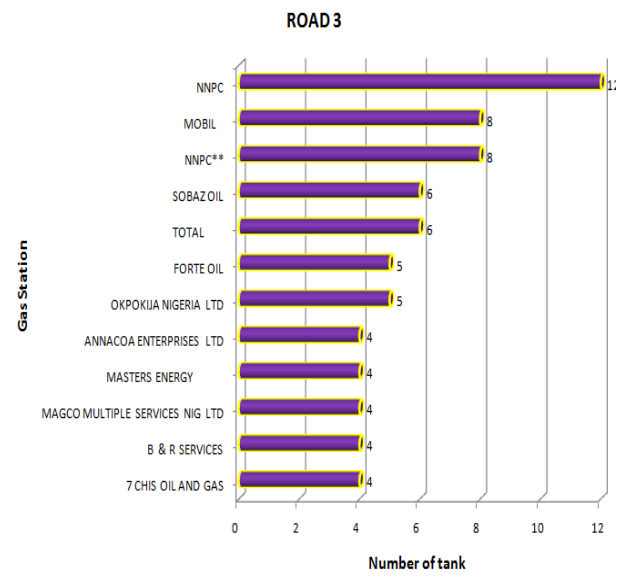
Fig 4.5; Graph of Gas Stations against Age and Number of USTs for Road 3

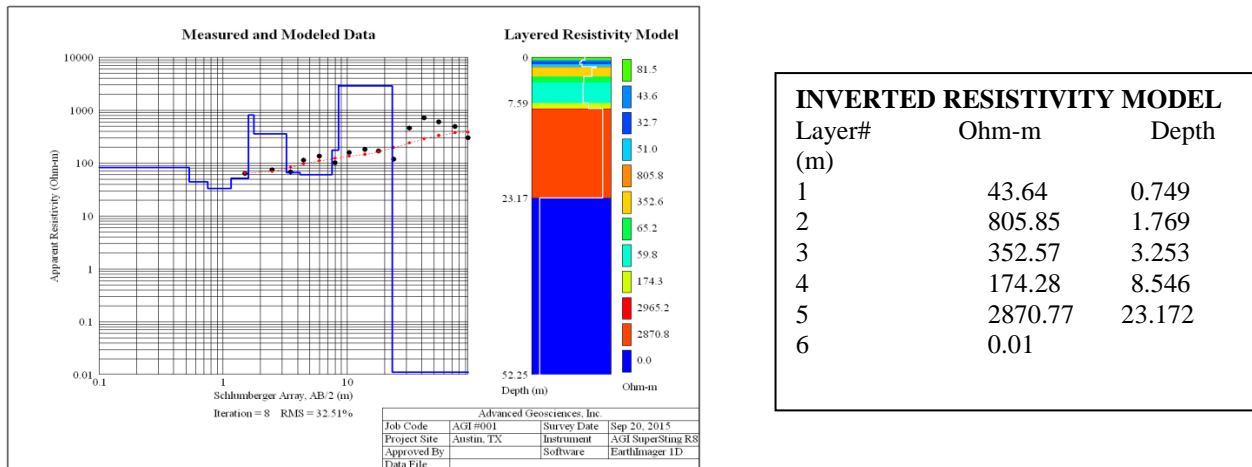
Inverted Resistivity model constrained to 6 geo-electric layers consisted predominantly of sand and gravel beds, indicating water table at depth of 23 m in road 1, 24.5 m in road 2 and 26.2 m in road 3 constrained to 7 layers as shown in fig 4.3, 4.4 and 4.5. This gave 24.5 m as average depth to water table across the area.

Fig. 4.6: VES for Road 1

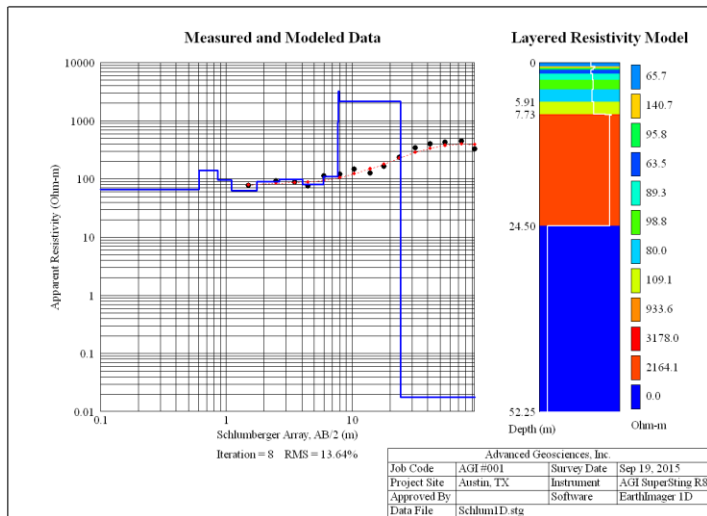
INVERTED RESISTIVITY MODEL		
Layer#	Ohm-m	Depth (m)
1	140.74	0.853
2	89.27	2.651
3	98.81	4.055
4	3177.99	7.882
5	2164.08	24.502
6	0.02

Figure 4.7: VES for Road 2

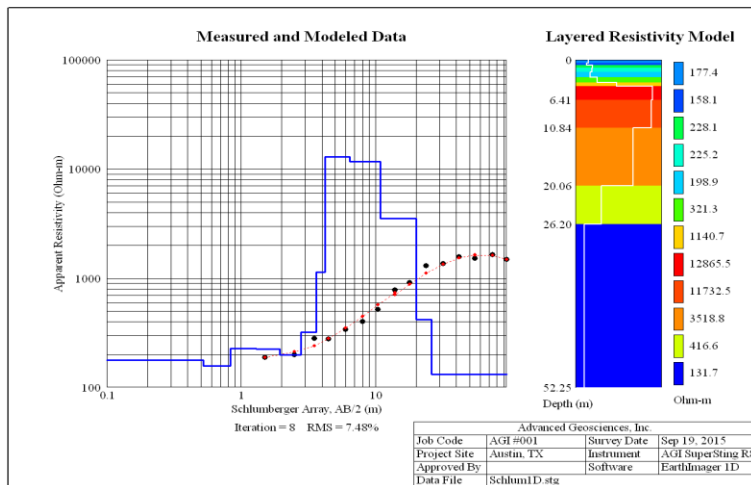
INVERTED RESISTIVITY MODEL		
Layer#	Ohm-m	Depth (m)
2	158.14	0.831
6	321.25	3.625
8	12865.5	6.414
9	11732.54	10.837
10	3518.78	20.062
11	416.63	26.200
12	131.68

Figure 4.8: VES for Road 3

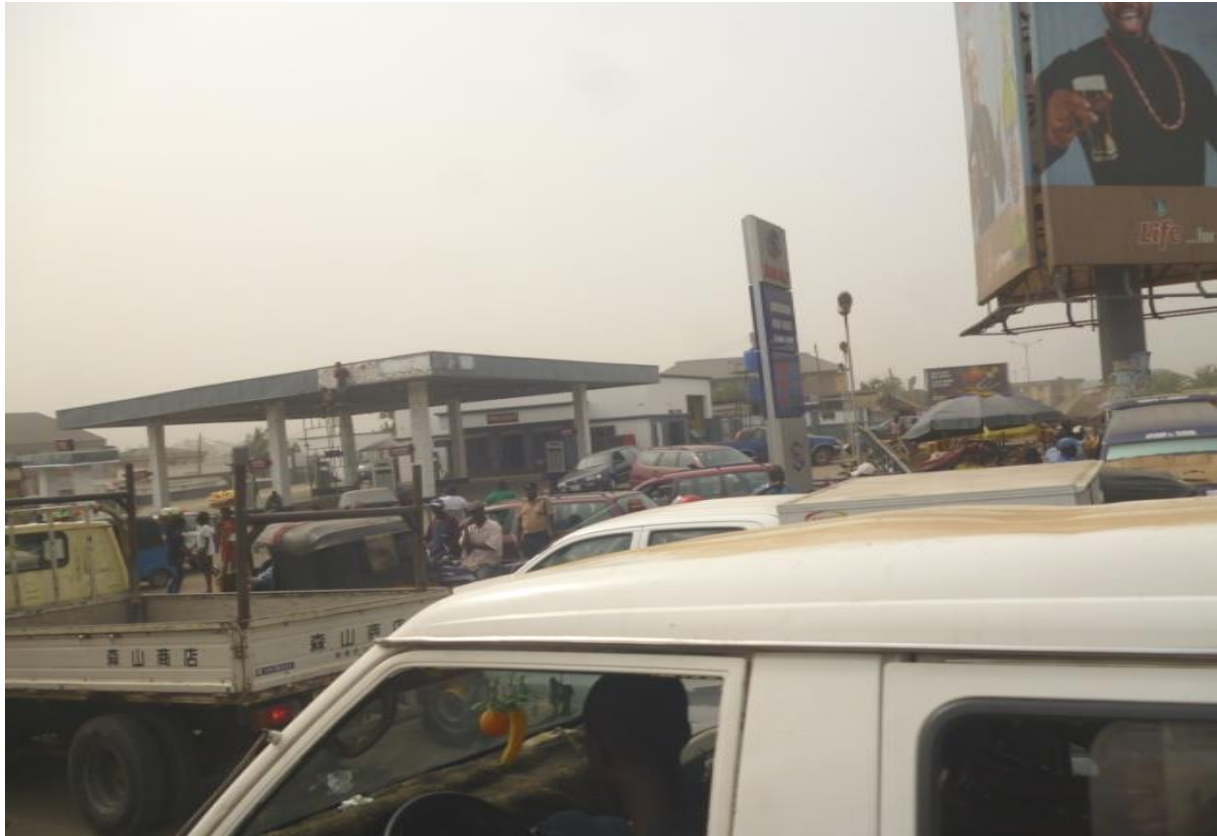
Plate 4.1 Frank Gilly Petrol Station at close proximity to public place

The result also revealed that, some of the petrol stations were operating at close proximities to markets, Banks, motor parks or other public areas as shown in Plate 4.1 and 4.2. However, based on their dates of location and history as obtained, it was obvious that it was the presence of some of these petrol stations that attracted the locations of most of those markets, commercial shops, motor parks, Banks and

For instance, Frank Dilly and Total Petroleum Nigeria Limited (Plate 4.1 &4.2) are located at less than 43m away from Weatheral roundabout , New Market/ Motor park, and other shops and human activities were built in 2001 and 1996 respectively (years after the markets were located). This might have contributed to the environmental problems such as indiscriminate/perennial waste disposal, noise and flooding the immediate neighbourhoods are facing.

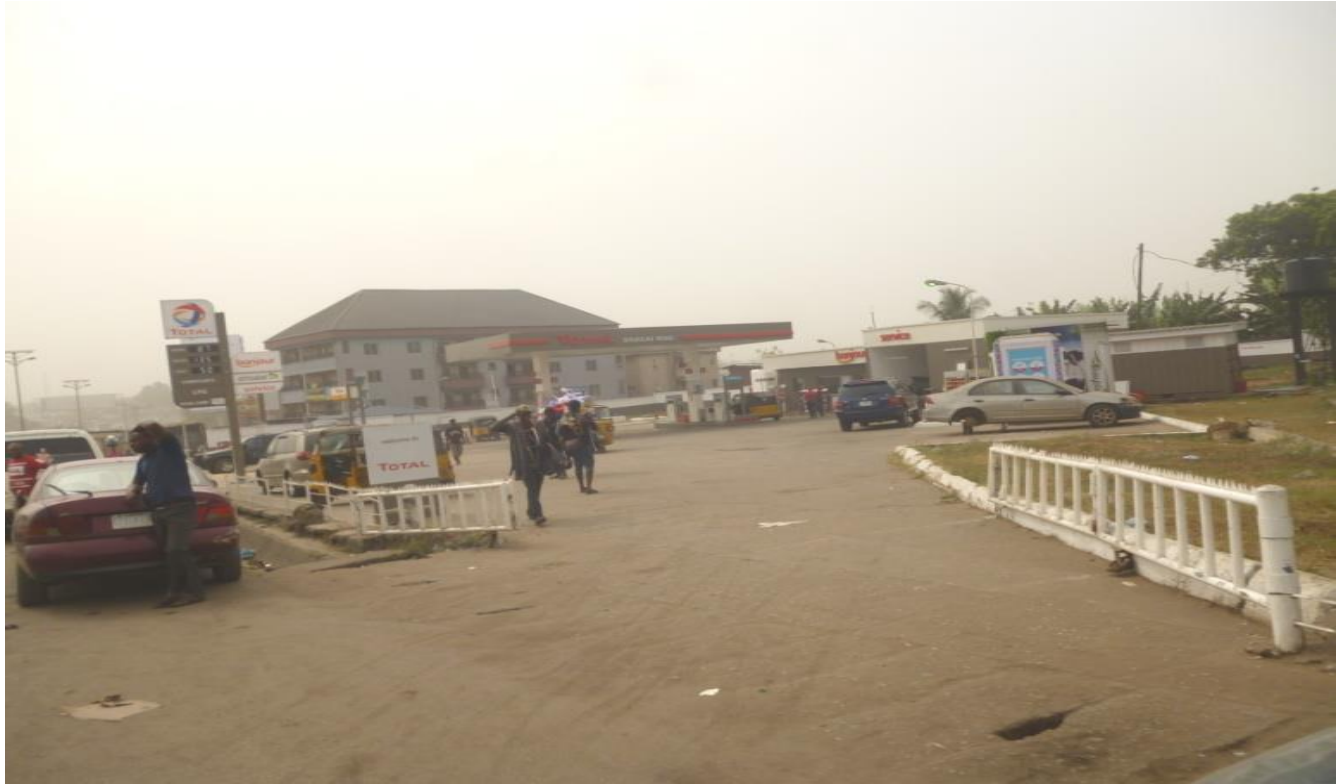
Plate 4.2 Total Petrol Station at close proximity to public place

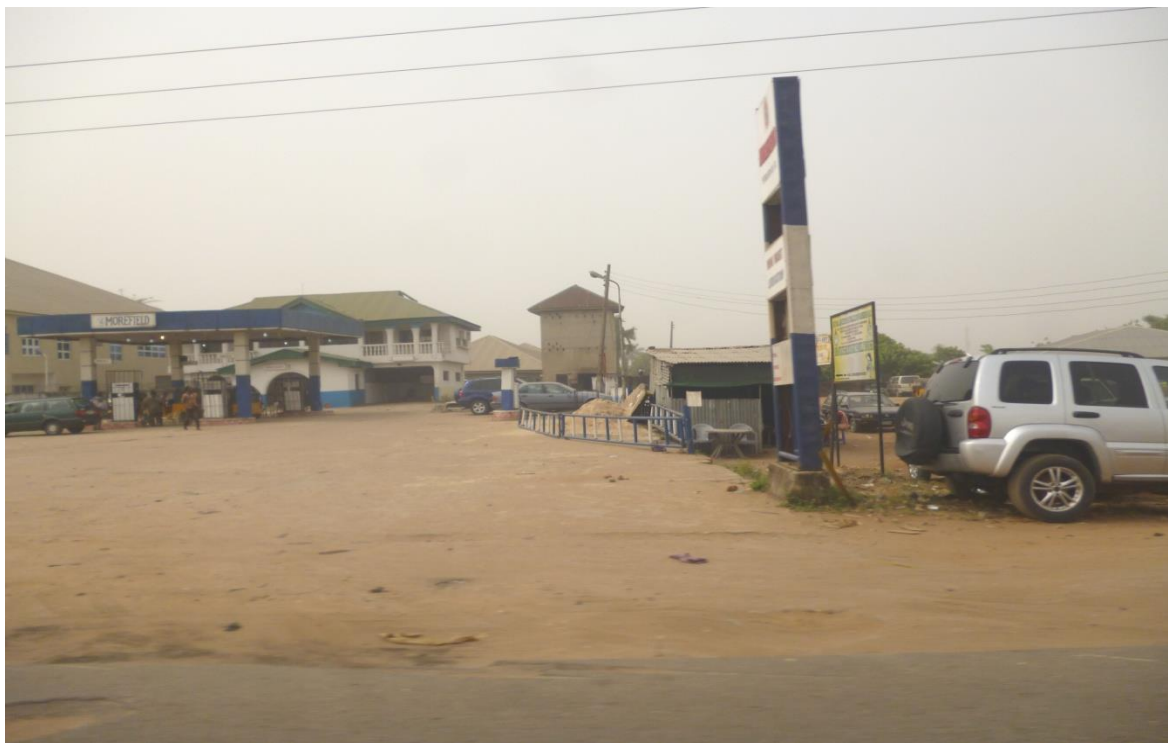
Plate 4.3: Morefield fuel station located at close proximity to residential buildings

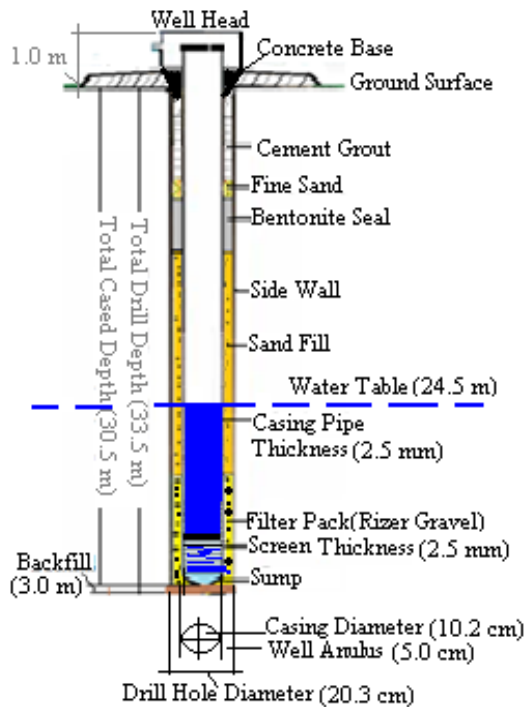
Considering the population of Federal University of Technology Owerri and Federal Polytechnic Nekede, both located in this area and the attendant population density, any leakage of petroleum product to the groundwater will represent a disaster to the area with serious physical and health consequences to the people. This result suggests that six monitoring wells at 500 m offset from each of the three roads reference coordinate be installed in the direction south-west. Fig. 4.7 is a typical design of a monitoring well considered very adequate in Owerri west.

Figure 4.10, Design of Groundwater Monitoring Well for Owerri-West

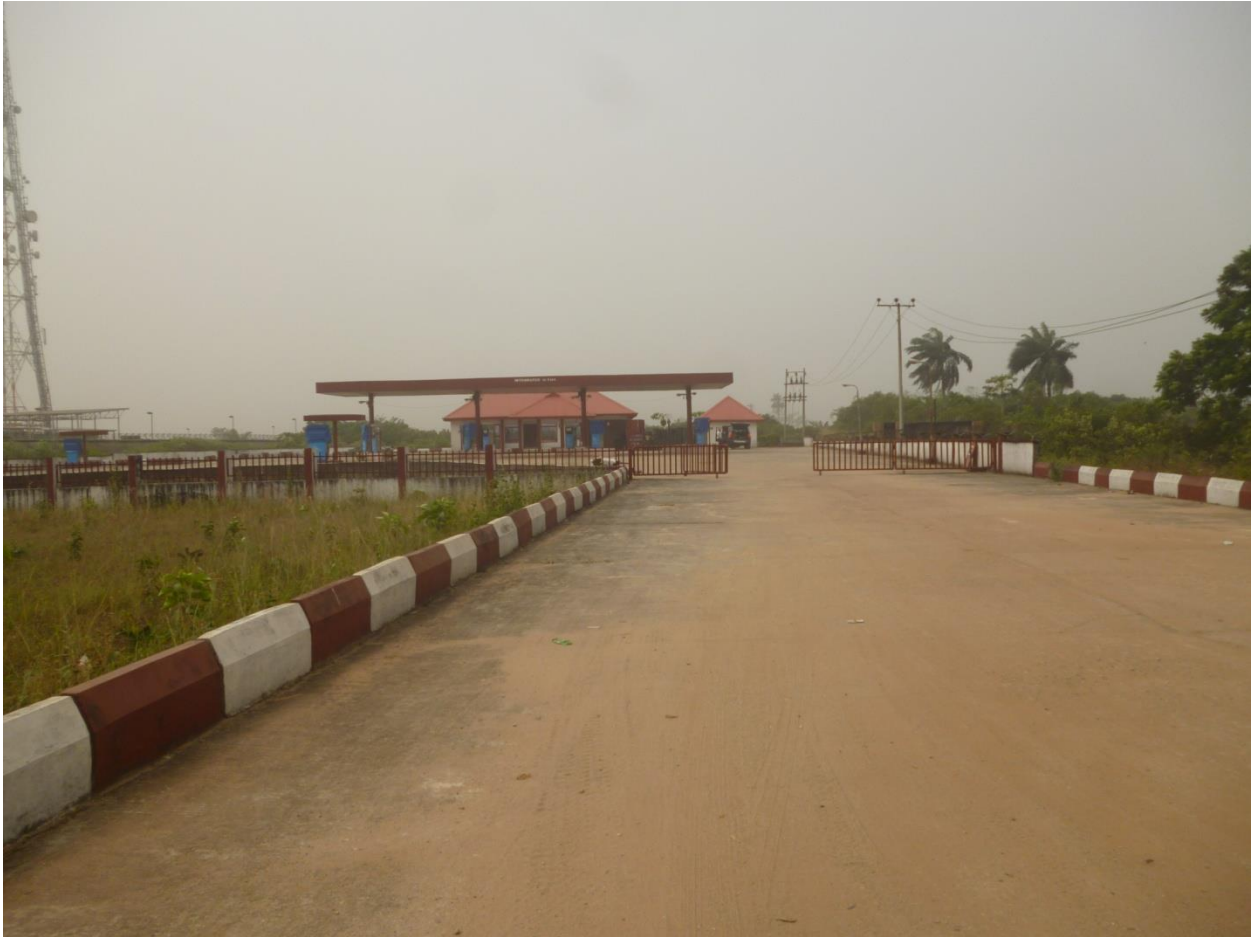
Integrated petrol station: properly situated
