**INVESTIGATION OF GEO-ENVIRONMENTAL HAZARDS AND
RECLAMATION OF ABANDONED BORROW PITS, SOUTH -
EASTERN, NIGERIA**

**A THESIS SUBMITTED TO
THE POSTGRADUATE SCHOOL
FEDERAL UNIVERSITY OF TECHNOLOGY, OWERRI**

**IN PARTIAL FULFILLMENT OF THE REQUIREMENTS FOR THE
AWARD OF THE DEGREE OF MASTER OF SCIENCE (M.Sc.) IN
ENVIRONMENTAL GEOLOGY**

FEBRUARY, 2016

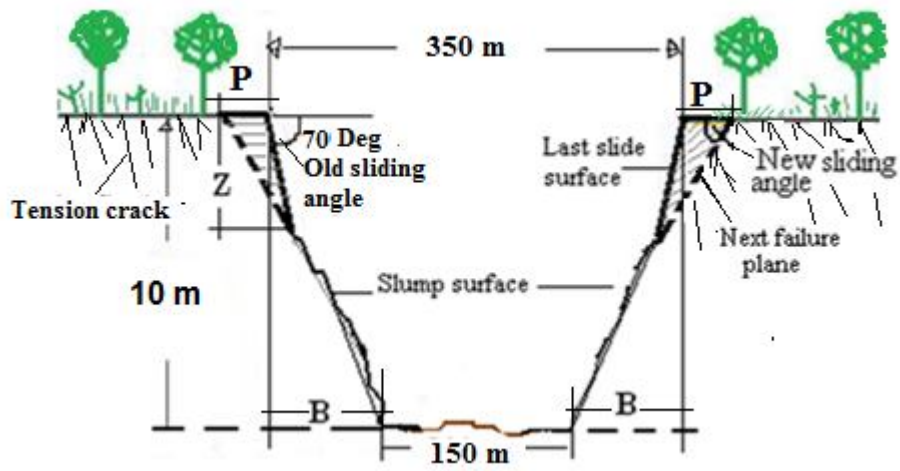
Figure 4a: Cross-sectional geometry of Emekuku pit

In the two sites visited there are issues of landslide which is a serious environmental problem in the area. Landslide is a down slope movement of rock and soil along slip surfaces is also associated with disturbance of the equilibrium which normally exists between stress and strain in material resting on slope. This relationship is dependent on factors like height, steepness of the slope, density and strength (cohesion and friction) of the material on the slope. The geometry of the two sites, Ihiagwa and Emekuku revealed a slope angle of between 70° to 80° (Figure 4a,b). The slopes were compromised during the excavation process. Also the pit slope has been weakened due to heavy rainfall common to the area from March to September. From the vertical electrical sounding carried out, the study area is a sandy geological formation resulting to higher permeability which will also account for groundwater movement and pore water pressure around the sloppy region giving rise to resultant mass movement of the soil on the sloppy surface. The resultant effect of landslide in the area has led to loss of lives and damage to properties. Community personnel interviewed affirmed that since the abandoned borrow pits where the community has suffered unquantified loss of properties. Porosity of the sandy soil and its moisture content as well as slope angle, have aided the occurrence of landslides in the area. The illustration of measurement procedure of the two sites (Figure 5).

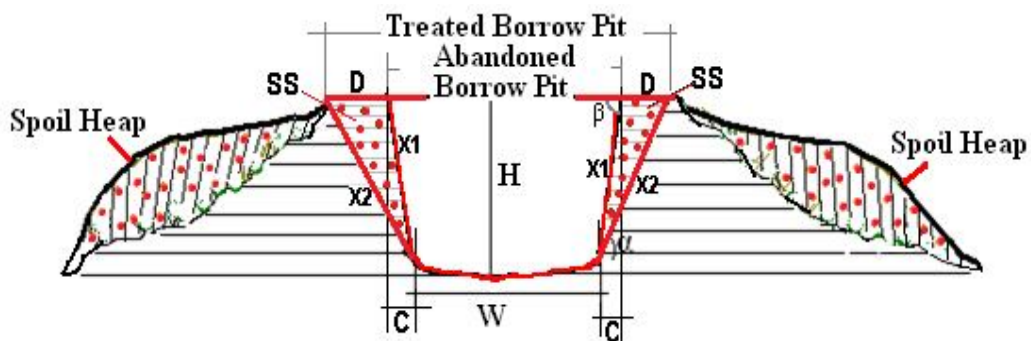
Figure 6: Excavation completed, Borrow pit abandoned

The classical approach used in designing open pit excavation is not applied in the study area. There is no pit design, and that implies no proper consideration to safety and possibility of sliding in the pits investigated. Critically, there is no consideration to the relationship between forces resisting sliding (B_f) associated with the sliding base distance (B) and the probability of Sliding (Figure 6) show force resisting sliding (C) possessed by the base rock and the overburden pressure (D) initiating sliding.

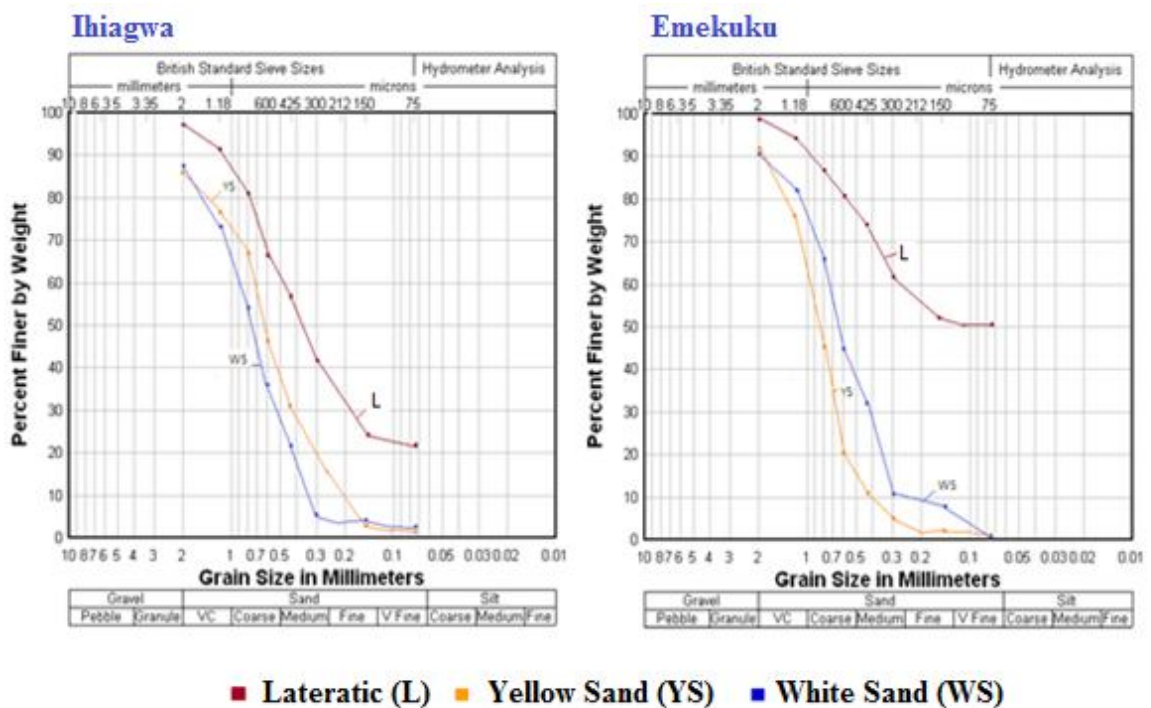
Figure 8: Showing Graph of Percentage Passing (%) against Grain Size (mm) at Ihiagwa and Emekuku

Grain size analysis of the borrow material suggests that the particle size ranges from very fine to very coarse, with significant clay silt content (Figure 8 and Table 1). This implies that the lateritic soil is plastic, and can be generally described as cohesive, and suitable as road fill material for which it is being used.

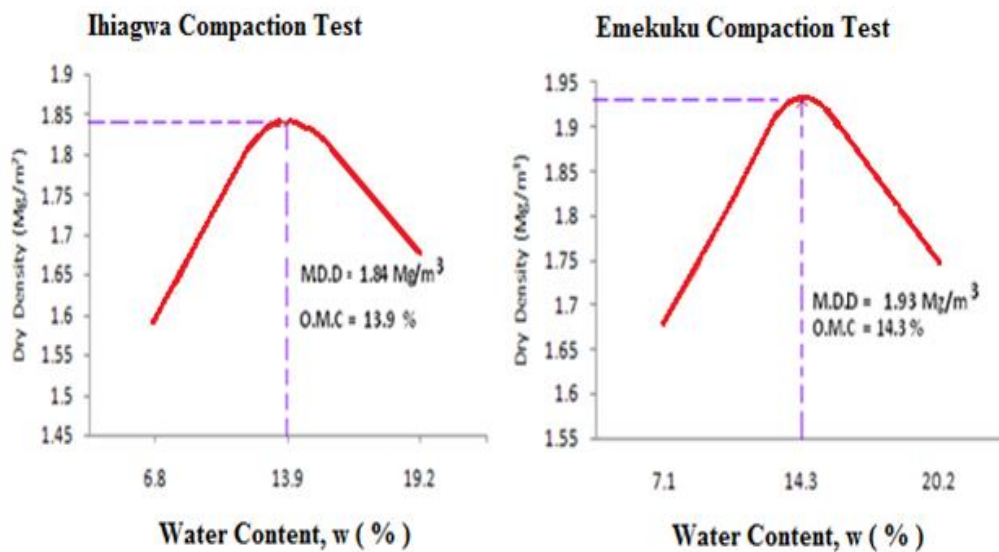
Figure 9: Showing Graph of Density (mg/m³) against Water Content, w (%)

A maximum dry density (MDD) range of 1.84 to 1.93 mg/m³ was measured at the two sites, with optimum moisture content (OMC) of 13.9% for Ihiagwa and 14.3% for Emekuku.

(Figure 9) the two samples tested, plasticity index (I_p) of 18.2% and 21.2% were obtained for the Ihiagwa and Emekuku sample respectively (Figure 10).

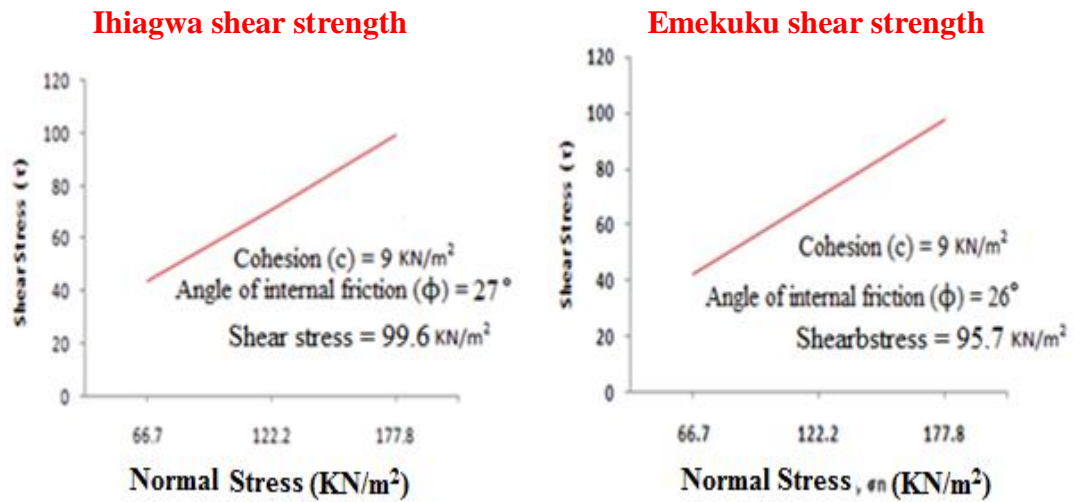
Figure 11: Showing graph of shear stress (τ) against normal stress, σ_n (KN/m²)

Shear strength of 99.6 KN/m² was obtained for Ihiagwa sample and 95.7 KN/m² for Emekuku sample with angles of internal friction of 27 and 26 degrees respectively (Figure 11). These values are significant to be considered when using the soil for road fill material for durability and good road quality.

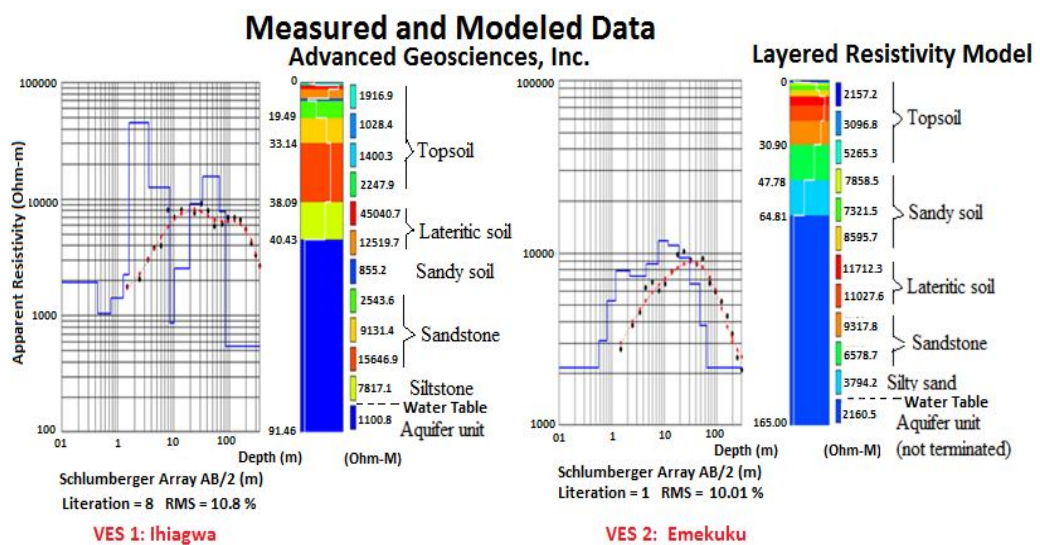
Figure 12: Showing 1-D Inversion Model Curves of Ihiagwa and Emekuku with 6 Lithologic Units

The model interpretation (VES 1 and 2) represent the depth, resistivity, lithology and color codes, corresponding to the interpretation of resistivity results (Figure 12).

It emphasizes on resistivity response of the various geo-electric layers identified at Ihiagwa, its lithology is in order of topsoil, lateritic sand, silty sand, sandstone, sand and gravel beds.
